WESTCO HOME INSPECTION, LLC

## RESIDENTIAL REPORT

1234 Main Street  
Riverside, CA 92507

09/29/2022 9:00AM

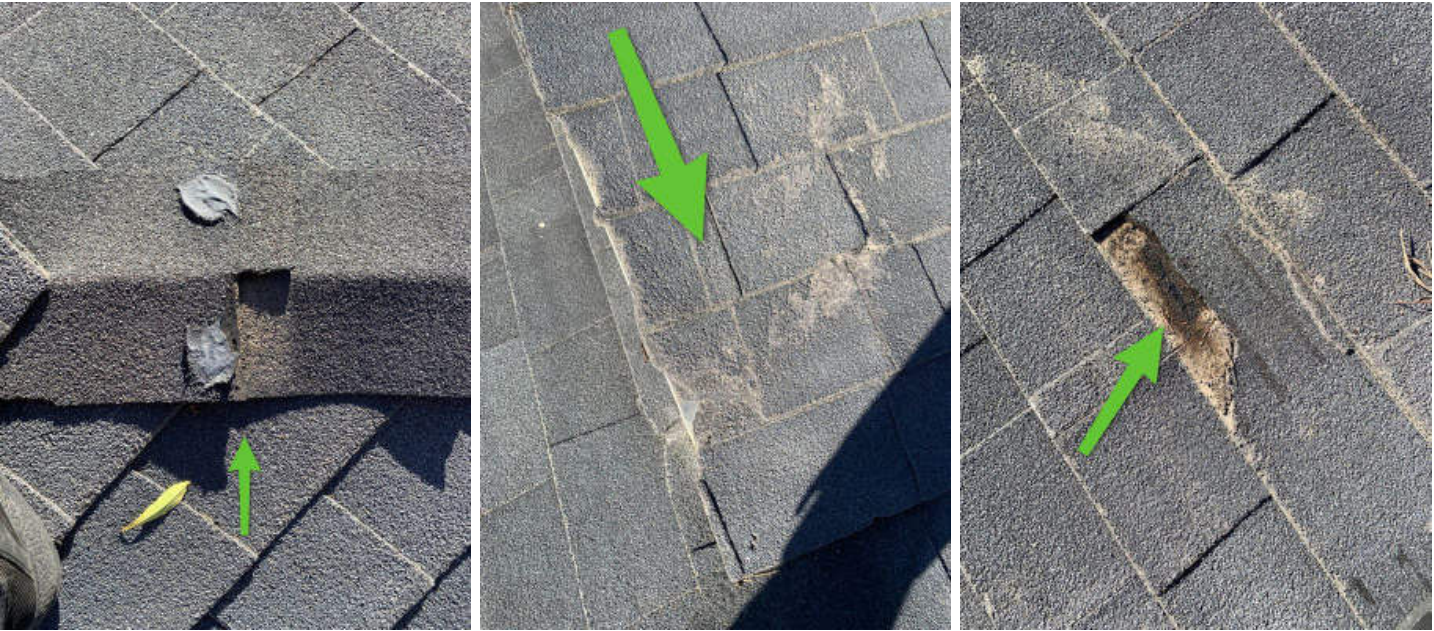
**DAMAGED (GENERAL)**

Roof coverings showed moderate damage. Recommend a qualified roofing professional evaluate and repair.

Contact a qualified roofing professional.

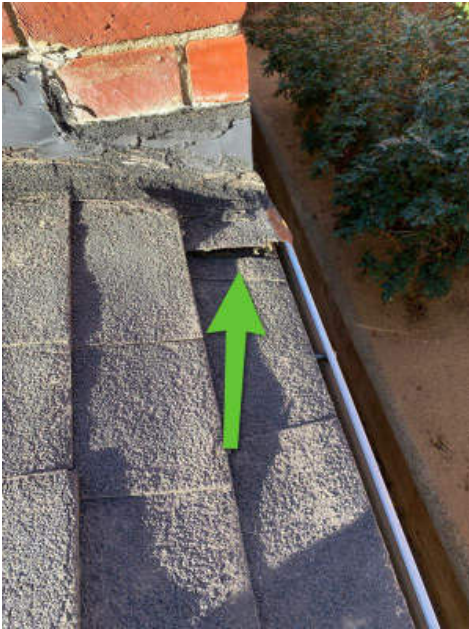
## 3.1.2 Coverings

**DELAMINATION**

Recommendation

Contact a qualified roofing professional.

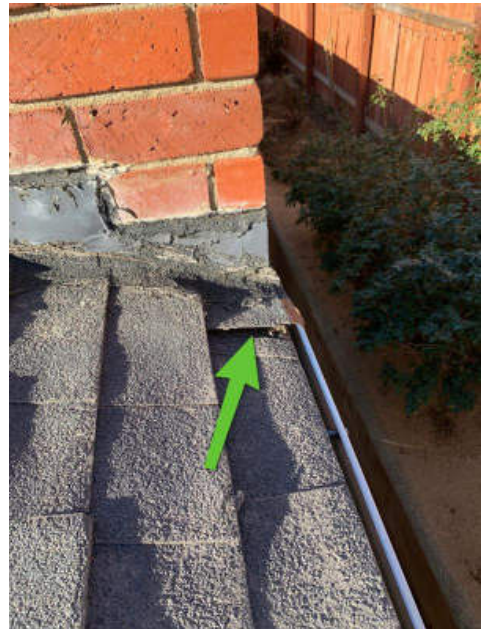
The asphalt shingle roof showed signs of delamination. Delamination is separation of the surface layer of asphalt. Recommend a qualified roofing contractor evaluate and repair to prevent further deterioration that results in leaking and moisture intrusion.

Contact a qualified roofing professional.

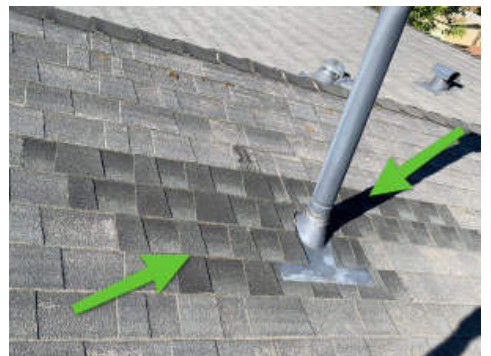
## 3.1.4 Coverings

**SPLITTING**

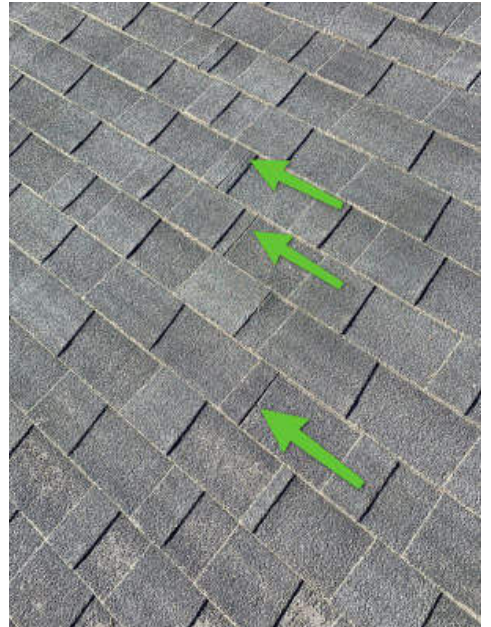
The asphalt composition shingle roof had torn or split shingles which could lead to moisture intrusion. Recommend a qualified roofing contractor repair.

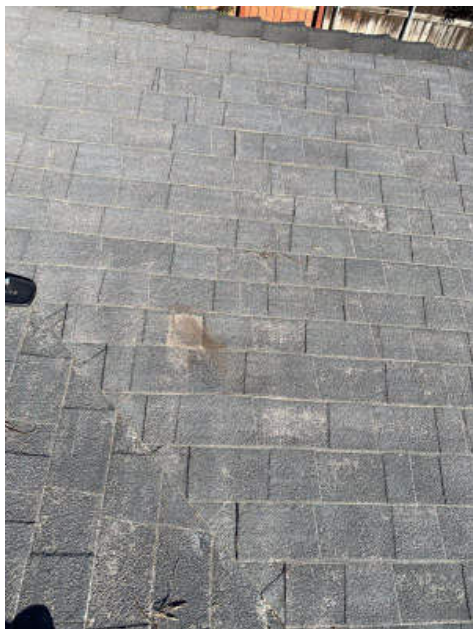
## 3.1.5 Coverings

**GRANULE DETERIORATION**

Asphalt shingles are essentially a layer of tar coated with granules of rock that protect the surface. As a roof wears, the granules can come off the surface, weakening the shingle. At the time of the inspection some granules appeared to missing. Recommend a qualified professional come and further assess.

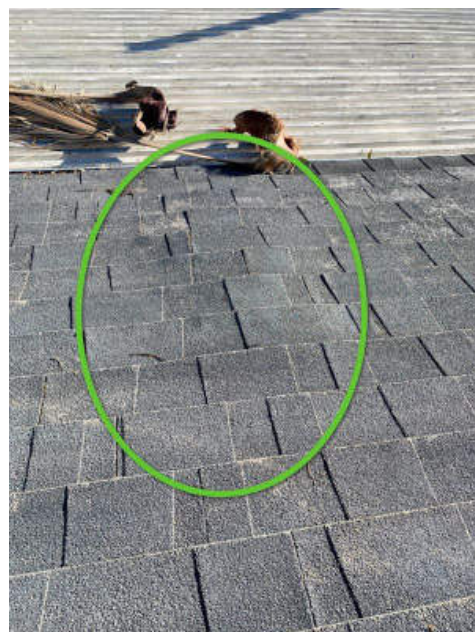
### 3.1.6 Coverings

#### BUCKLED SHINGLES

One or more sections of the roof were buckled at the time of the inspection. Moisture in the roof sheathing or felt paper can cause shingles to expand and buckle. This typically occurs when the sheathing is installed too tightly so it cannot expand and contract. It could also indicate poor attic ventilation. Recommend a qualified professional's further assessment.

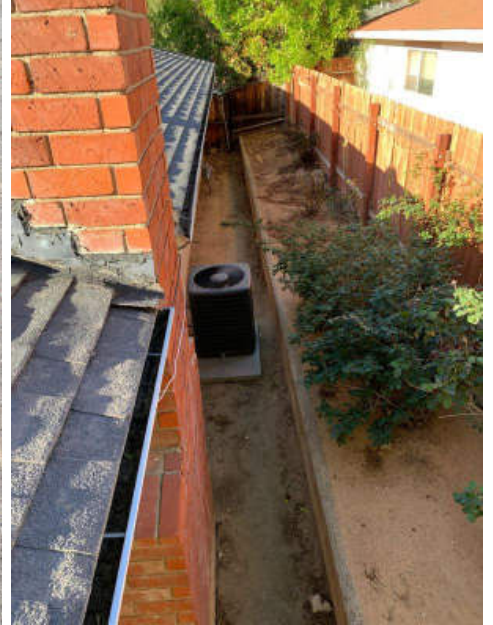
Debris had accumulated in the gutters. Recommend cleaning to facilitate water flow.

Recommended DIY Project

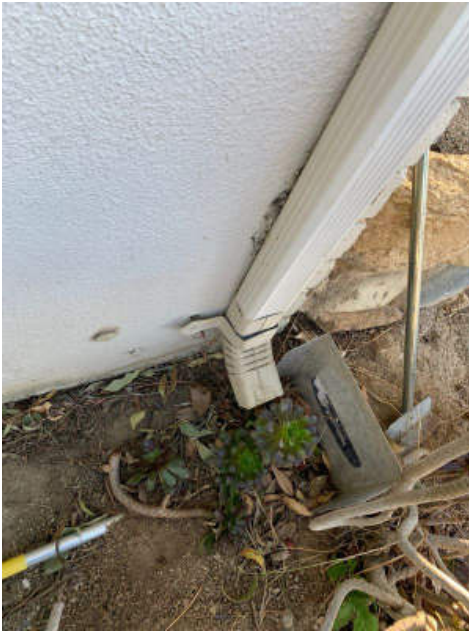
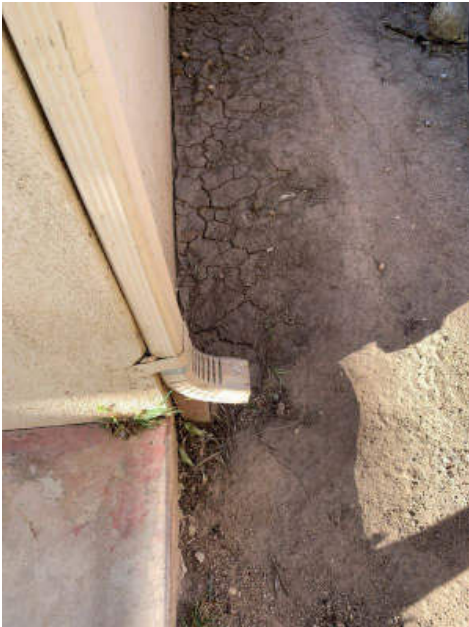
## 3.2.2 Roof Drainage Systems

**DOWNSPOUTS DRAIN NEAR HOUSE**

## Recommendation

Contact a handyman or DIY project

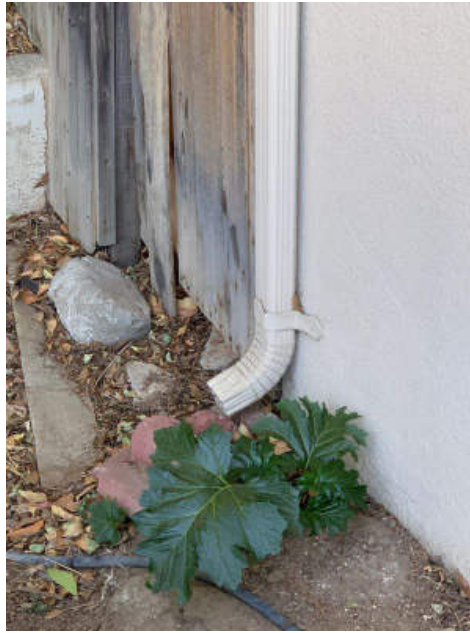
One or more downspouts drained too close to the home's foundation. This can result in excessive moisture in the soil at the foundation, which can lead to foundation/structural movement. Recommend a qualified contractor adjust downspout extensions to drain at least 6 feet from the foundation.

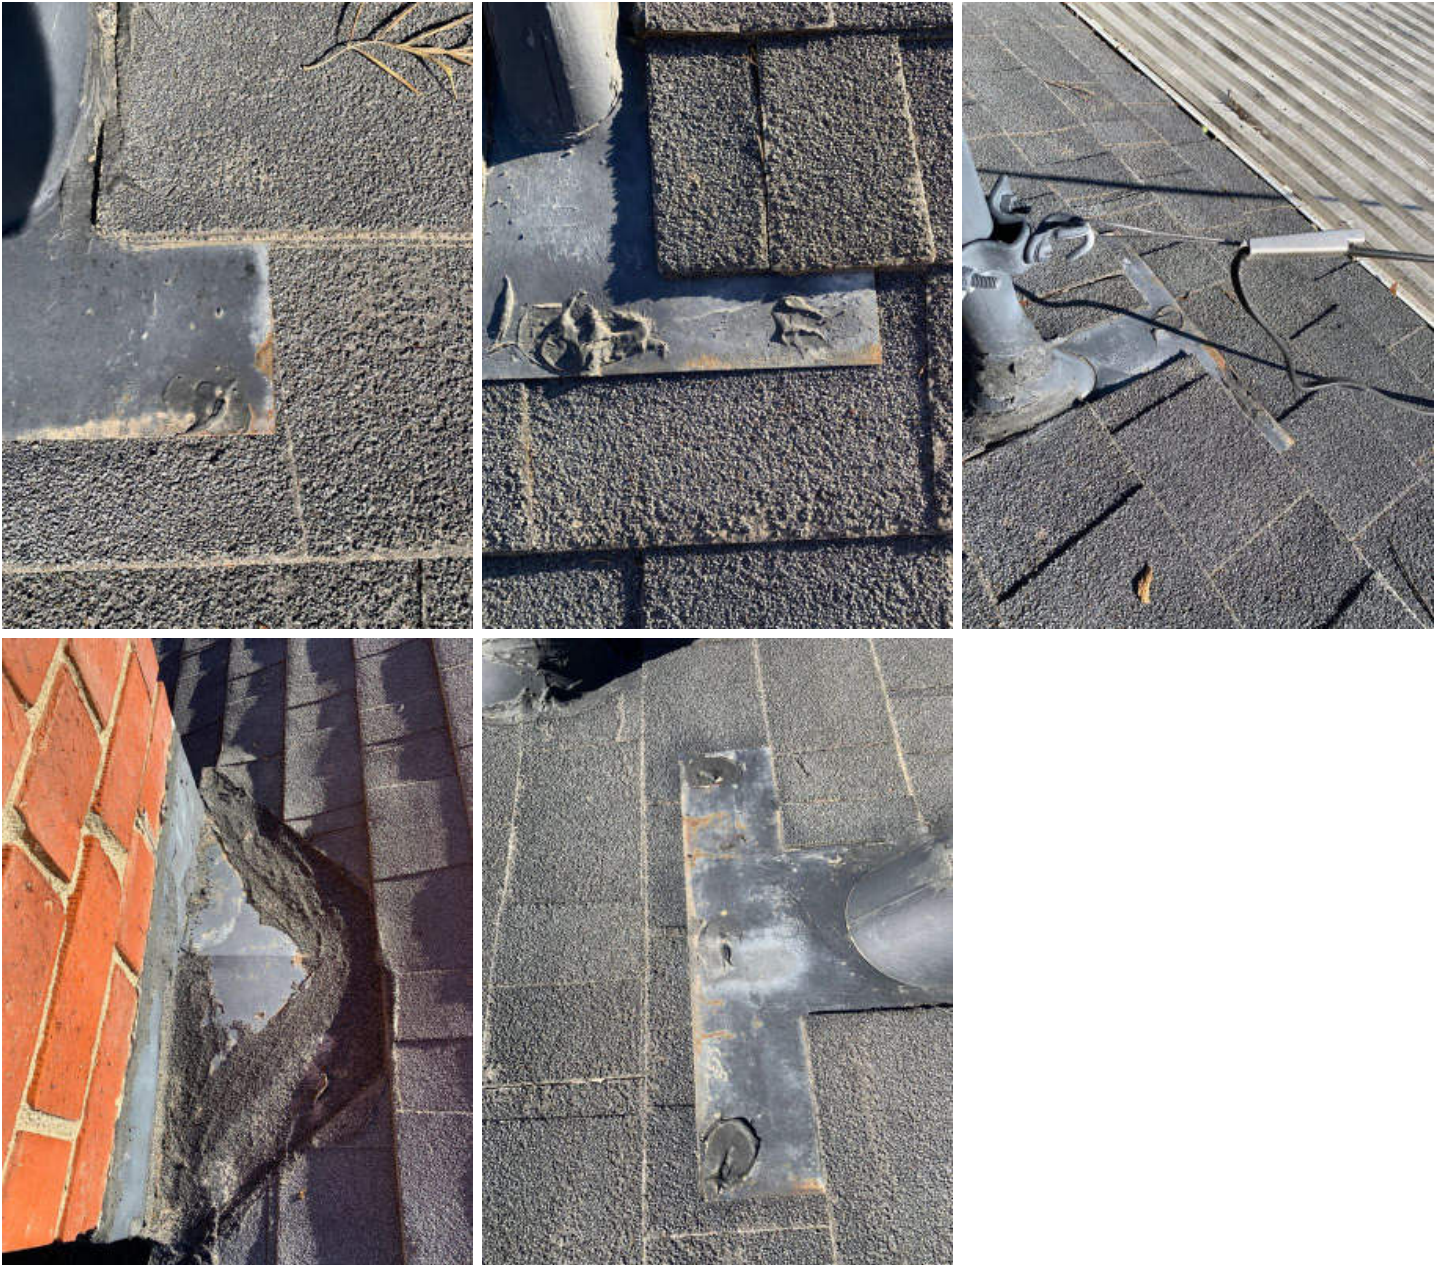
## 3.3.1 Flashings

**CORRODED - MINOR**

Roof flashing showed signs of corrosion, but are still in working condition. Flashing should be monitored to prevent severe corrosion leading to moisture intrusion.

Recommend monitoring.

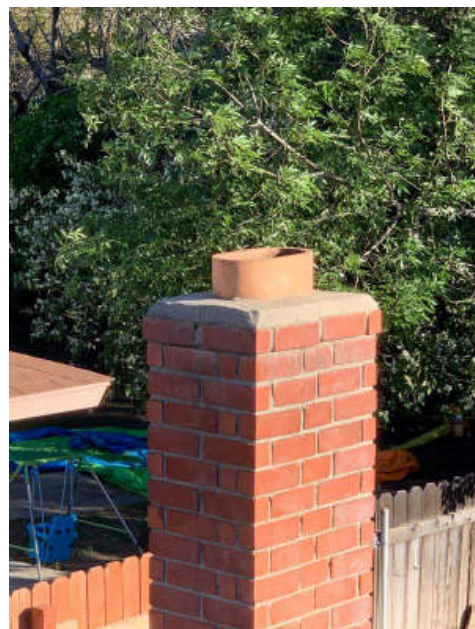
#### **CHIMNEY CAP MISSING**

No chimney cap was observed. This is important to protect from moisture intrusion and protect the chimney. Recommend installation.

Contact a handyman or DIY project

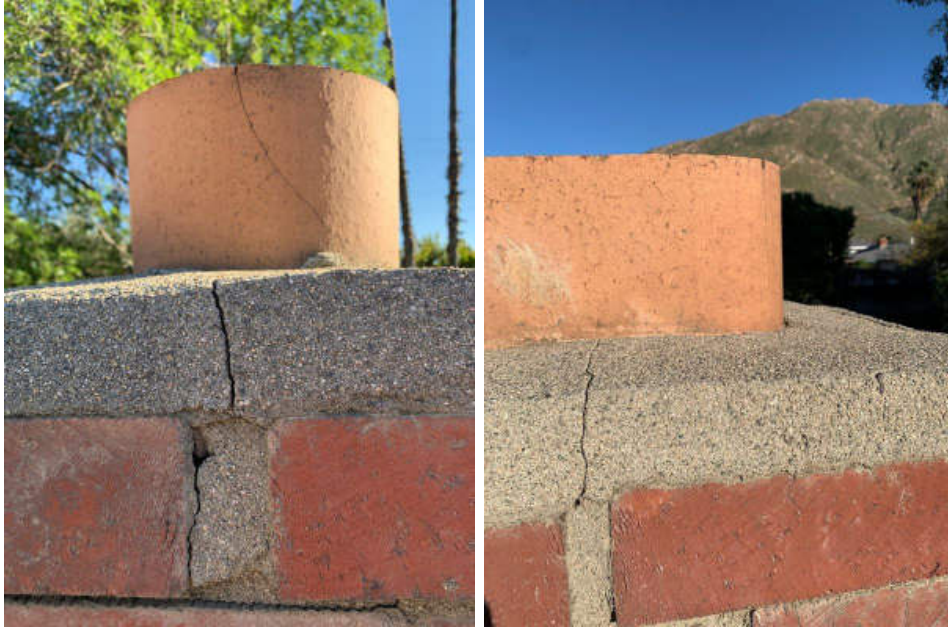
## 3.4.2 Skylights, Chimneys &amp; Other Roof Penetrations

**CHIMNEY FLUE CRACKED - MINOR**

The chimney flue had one or more cracks, which can lead to further damage to the chimney structure. Recommend repair.

Contact a qualified chimney contractor.

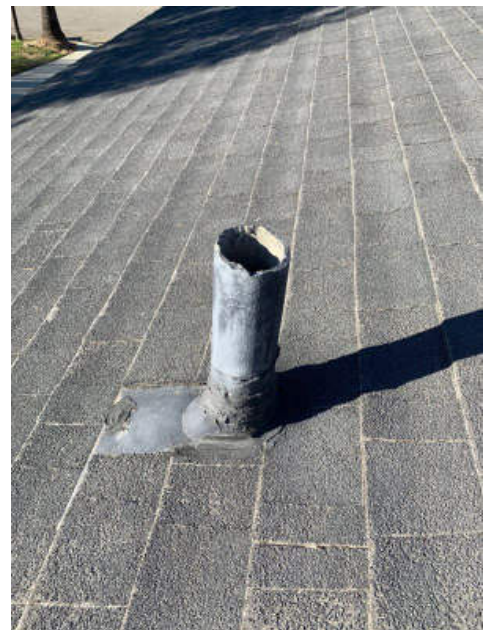
## 3.4.3 Skylights, Chimneys &amp; Other Roof Penetrations

**FLUE/VENT DAMAGED**

One or more of the flues/vents showed signs of damaged at the time of the inspection. Recommend repair.

Contact a qualified professional.

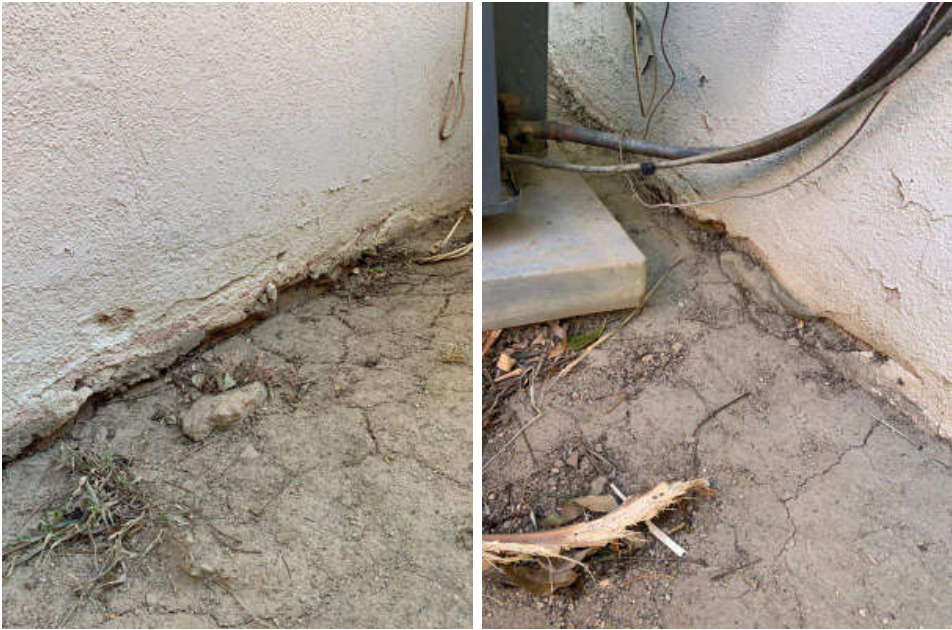
DETERIORATION - MAJOR

Moderate to major deterioration was observed at one or more points on the exterior. Recommend consulting with a stucco expert.

Contact a qualified siding specialist.

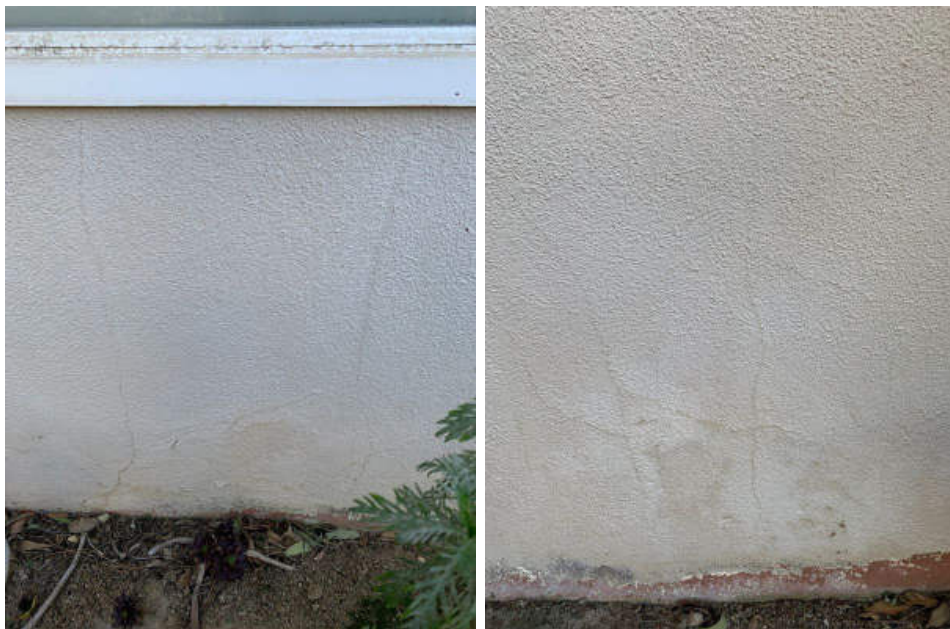
4.1.2 Siding, Flashing & Trim

CRACKING - MINOR

Siding showed cracking in one or more places. This is a result of temperature changes, and typical as homes with stucco age. Recommend monitoring.

Recommend monitoring.

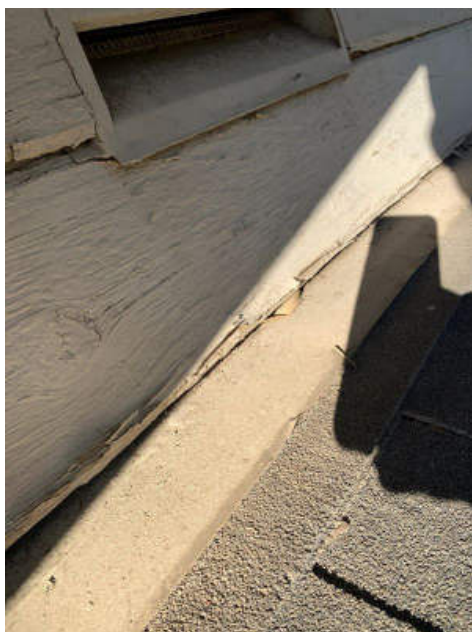
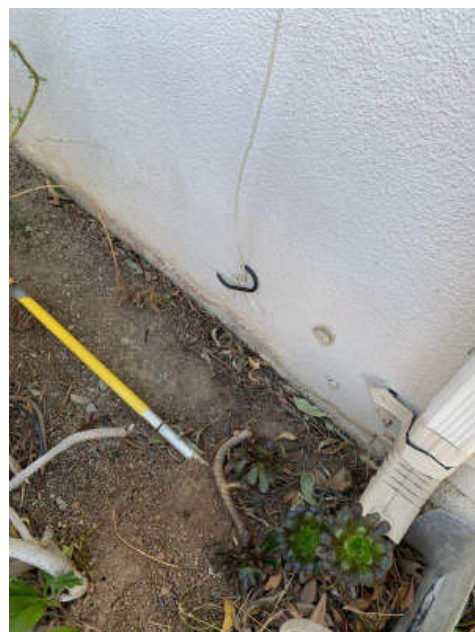
#### 4.1.3 Siding, Flashing & Trim

### EVIDENCE OF WATER INTRUSION

Siding showed signs of water intrusion. This could lead to further siding deterioration and/or mold. Recommend a qualified siding contractor evaluate and repair.

Contact a qualified siding specialist.

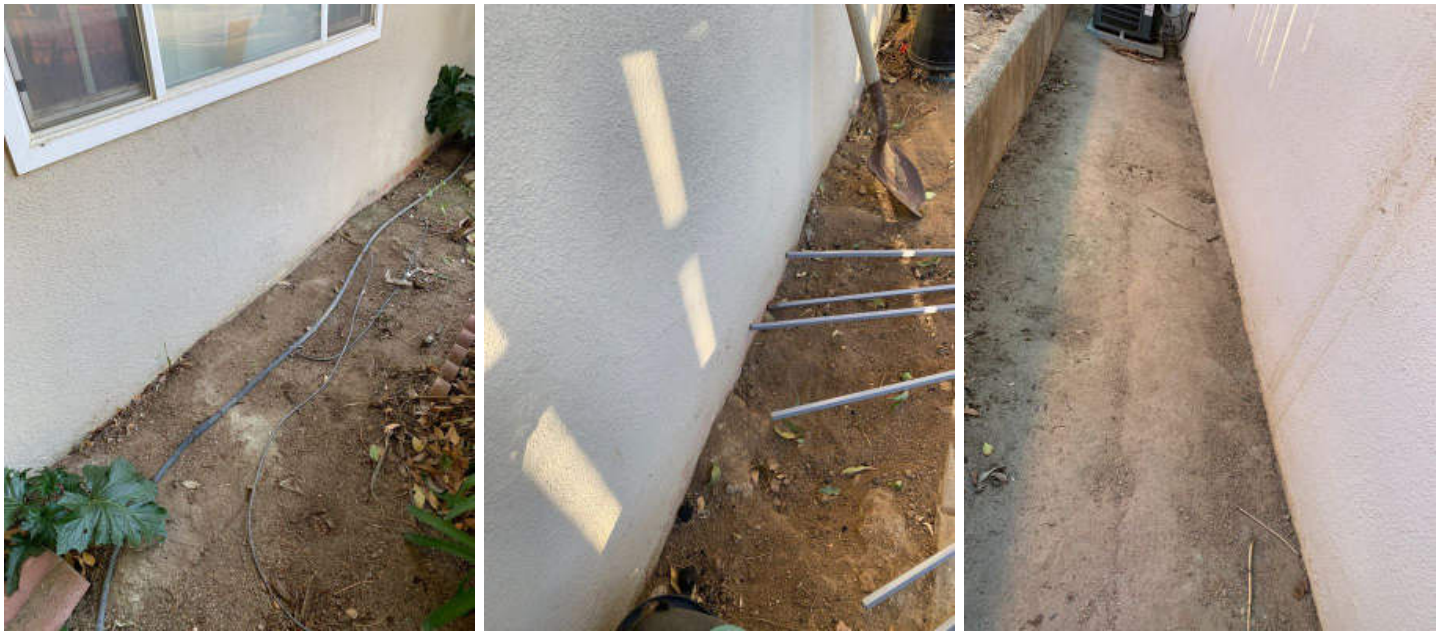
#### 4.1.4 Siding, Flashing & Trim

Inadequate clearance between siding and ground was observed. Recommend a minimum ground clearance between bottom of siding and ground of 4".

Recommend monitoring.

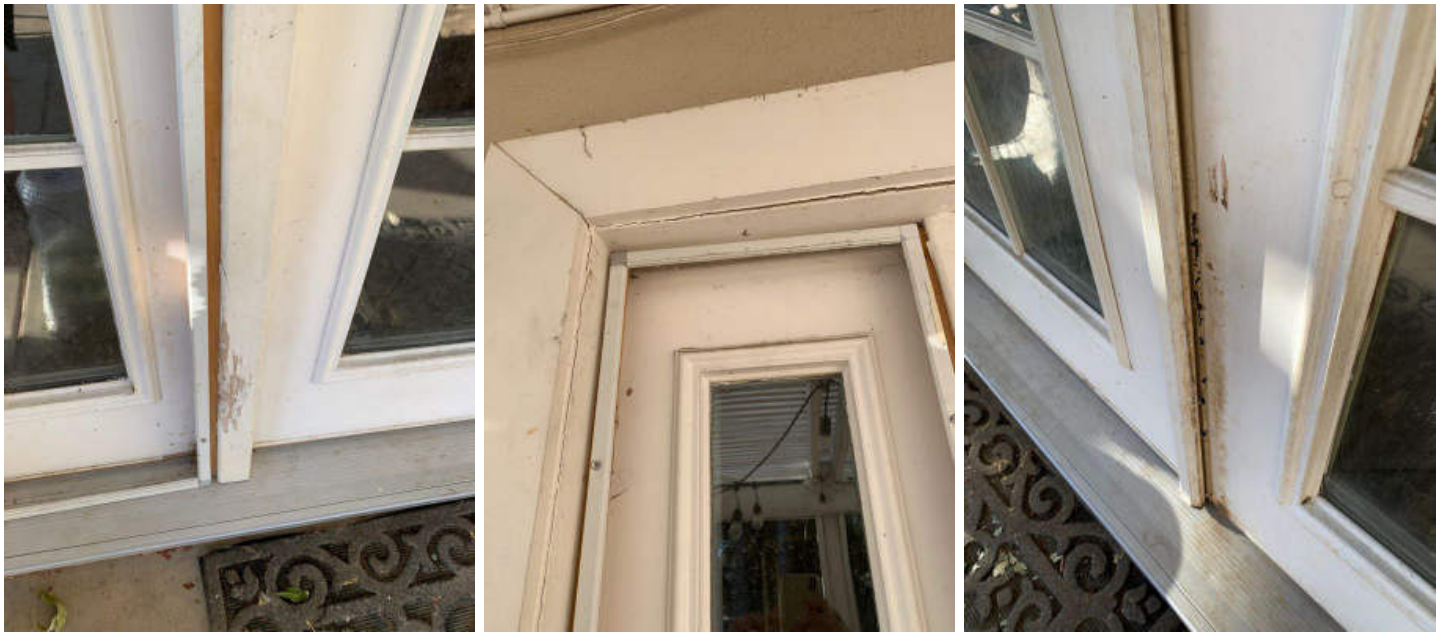
4.2.1 Exterior Doors

**DOOR SILL/TRIM**

Door sill and/or trim was loose, deteriorated or worn and repair or replacement should be considered.

Recommendation  
Contact a handyman or DIY project

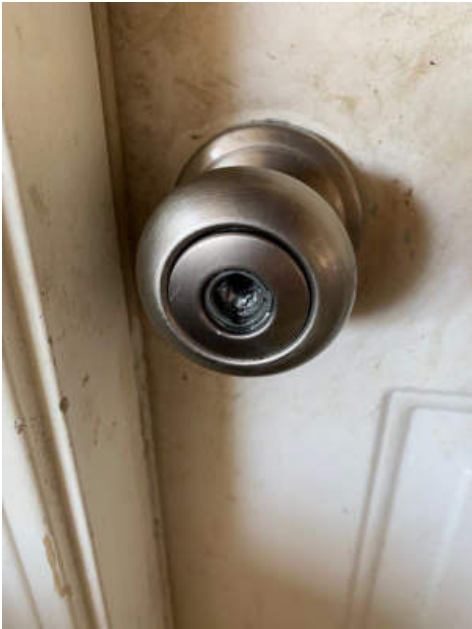
4.2.2 Exterior Doors

**HARDWARE DAMAGED**

One or more pieces of door hardware were damaged. Recommend repair or replace.

Recommendation  
Recommended DIY Project

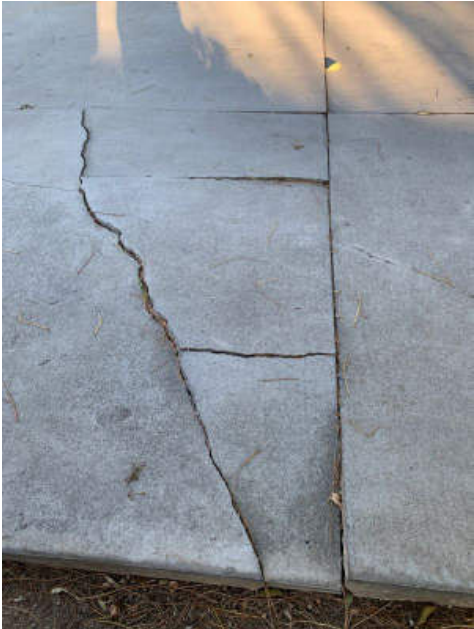
4.3.1 Walkways, Patios & Driveways

**DRIVEWAY CRACKING - MAJOR**

Major cracks observed. Recommend concrete contractor evaluate and replace.

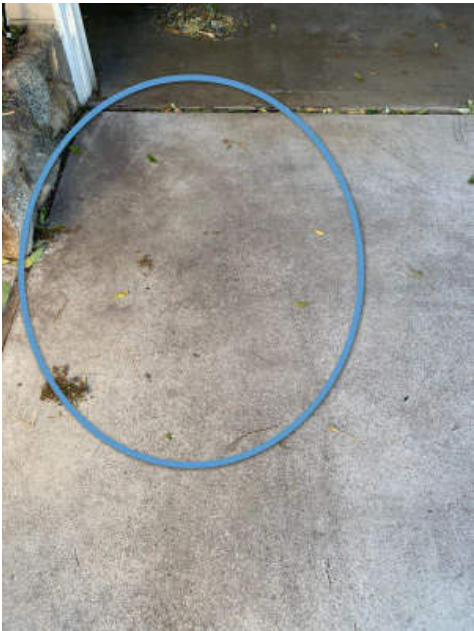
The driveway had a negative slope and drained towards the structure. Recommend a driveway contractor evaluate and repair.

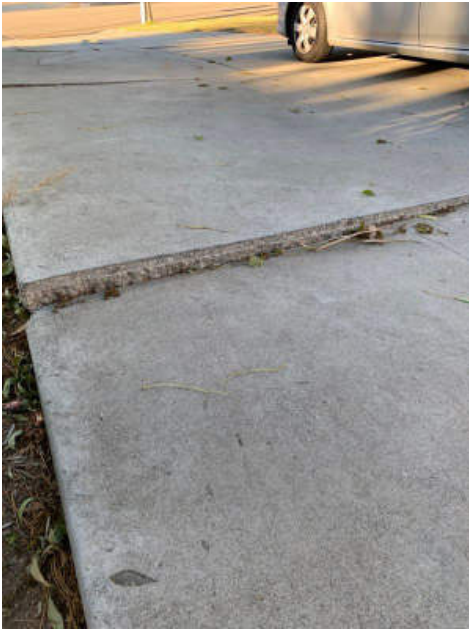
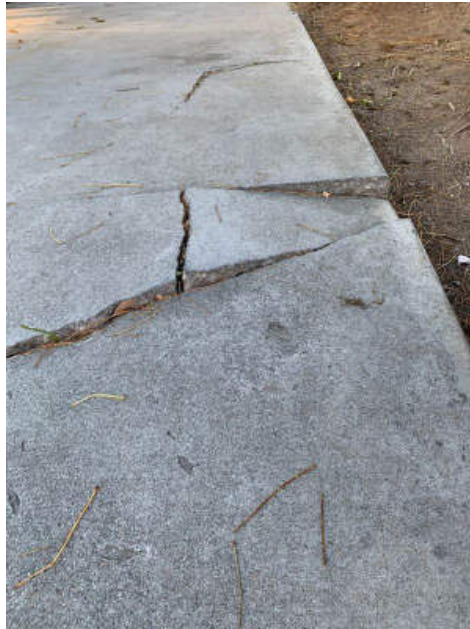
#### 4.3.5 Walkways, Patios & Driveways

##### **PATIO CRACKING - MINOR**

Recommendation

Recommend monitoring.

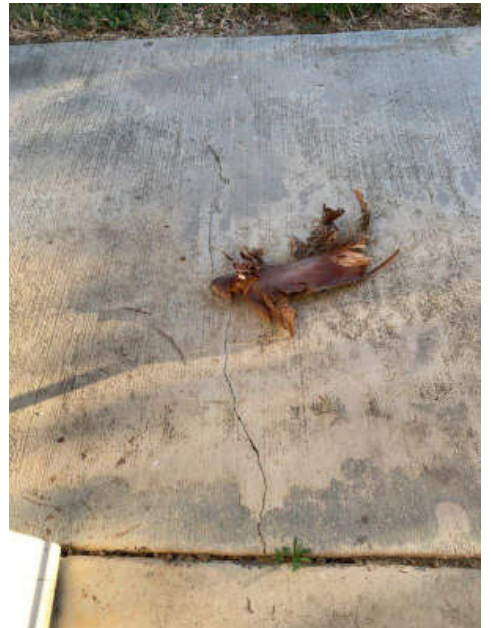
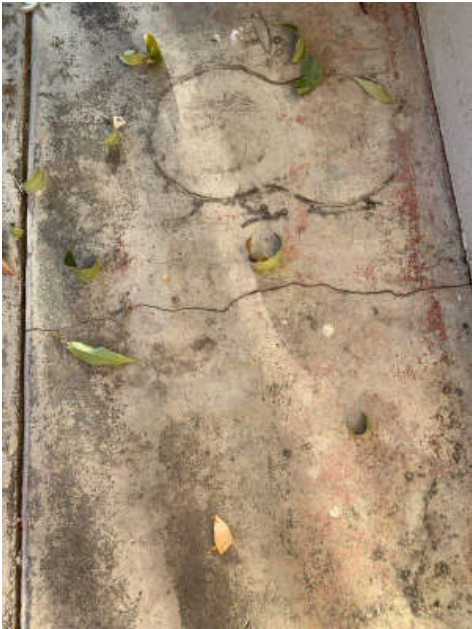
Normal settling & cracking observed. Recommend monitor and/or patch/seal.

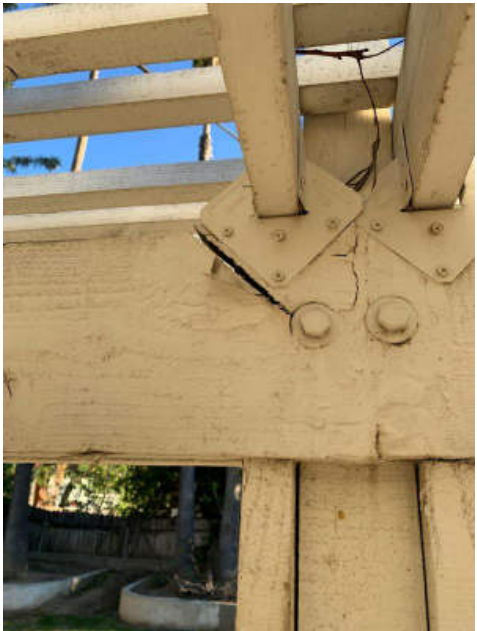
4.5.1 Eaves, Soffits & Fascia

**EAVES - DAMAGED**

Maintenance Item

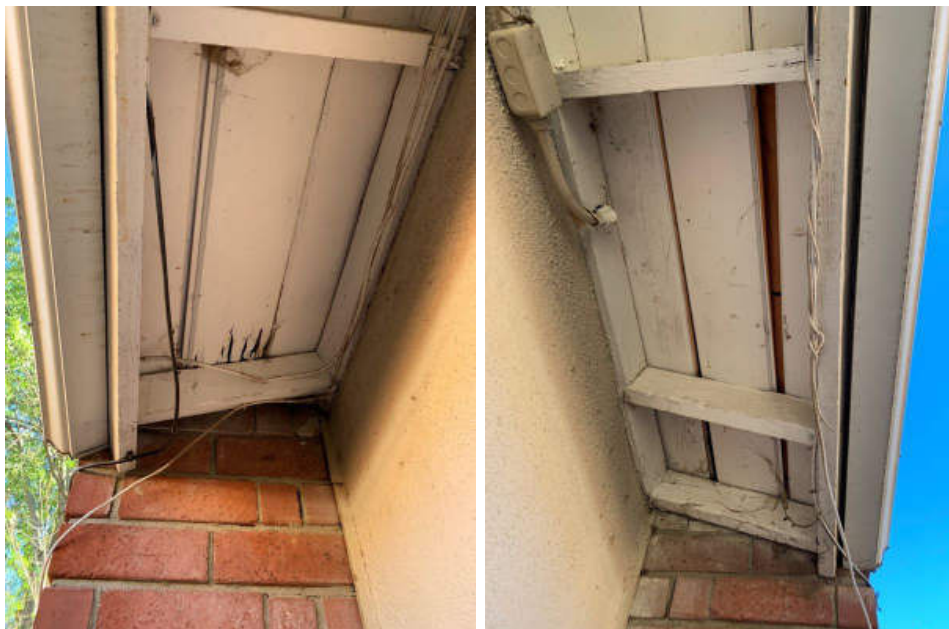
#### 4.5.2 Eaves, Soffits & Fascia

##### **FASCIA - DAMAGED**

Recommendation

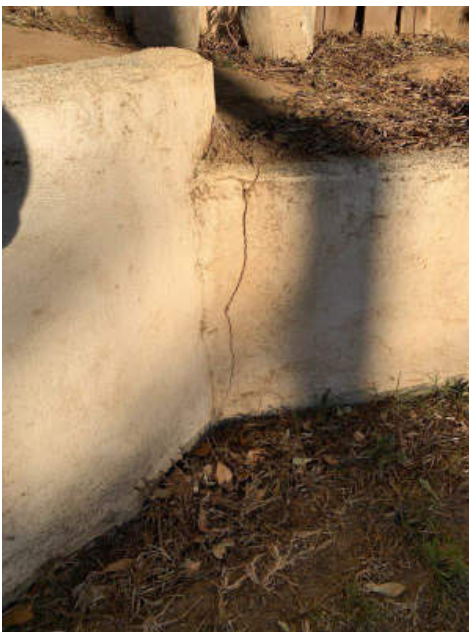
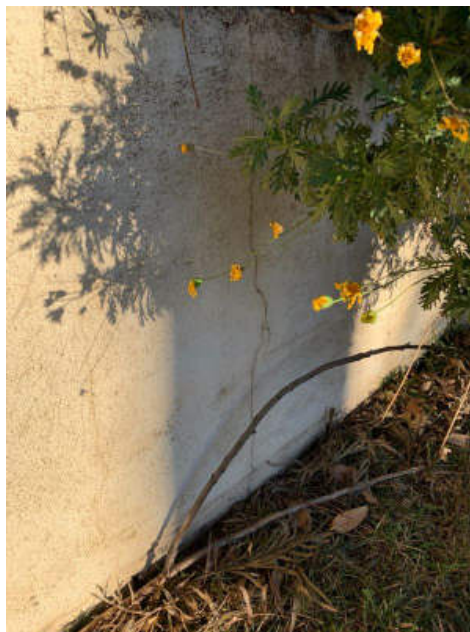
#### 4.6.2 Vegetation, Grading, Drainage & Retaining Walls

##### **RETAINING WALL CRACKS**

Retaining wall was showing signs of failing. Recommend monitoring or repair.

Recommend monitoring.

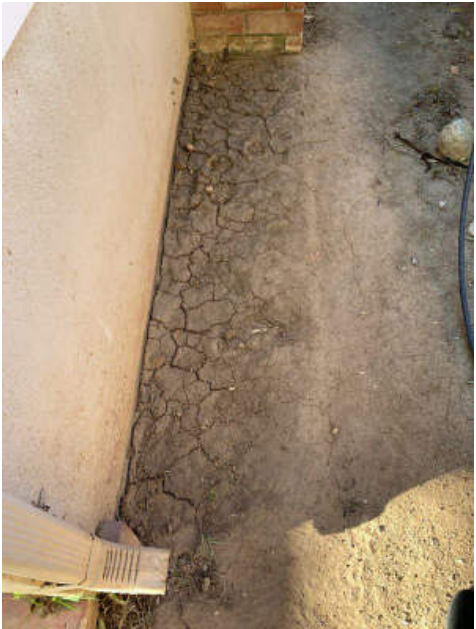
#### 4.6.3 Vegetation, Grading, Drainage & Retaining Walls

Standing water observed, which could indicate poor drainage and/or grading. Recommend monitor and/or have landscaper correct.

Recommendation  
Contact a qualified landscaping contractor

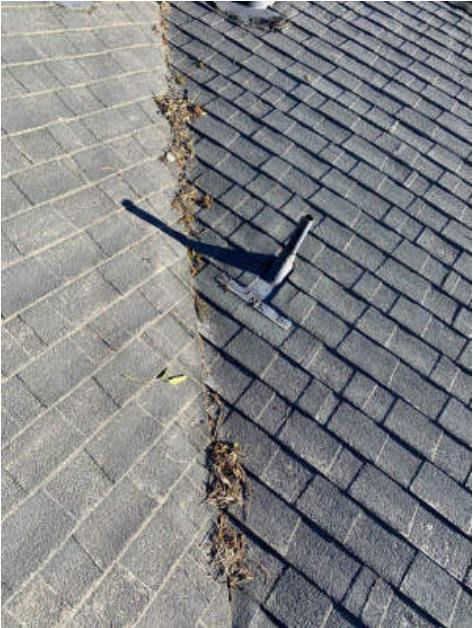
4.6.4 Vegetation, Grading, Drainage & Retaining Walls

**TREE DEBRIS ON ROOF**

Tree debris observed on roof. This can cause improper drainage to gutters and downspouts. Recommend clearing debris.

Recommendation  
Contact a handyman or DIY project

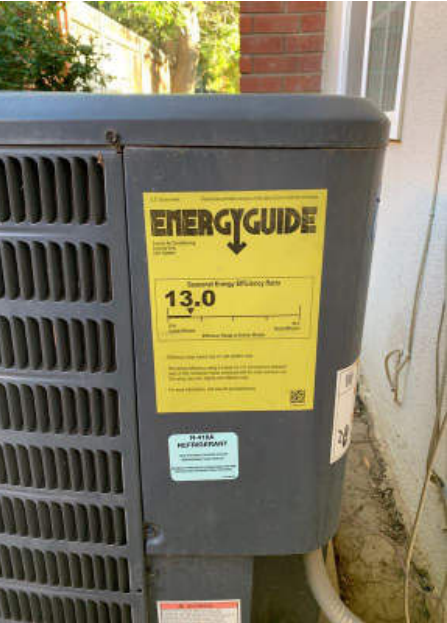
| <b>Cooling Equipment: SEER Rating</b><br>13 SEER<br><br>Modern standards call for at least 13 SEER rating for new install.<br>Read more on energy efficient air conditioning <a href="#">at Energy.gov</a> . | | |

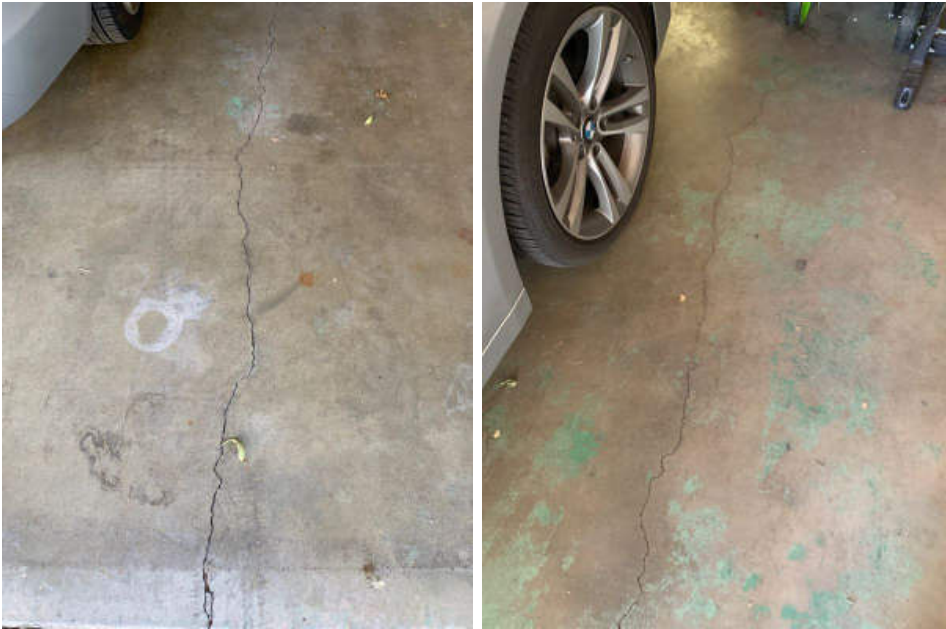
8.2.1 Floor

### CRACKING

Cracking was visible in the garage floor. Recommend monitoring.

Recommend monitoring.

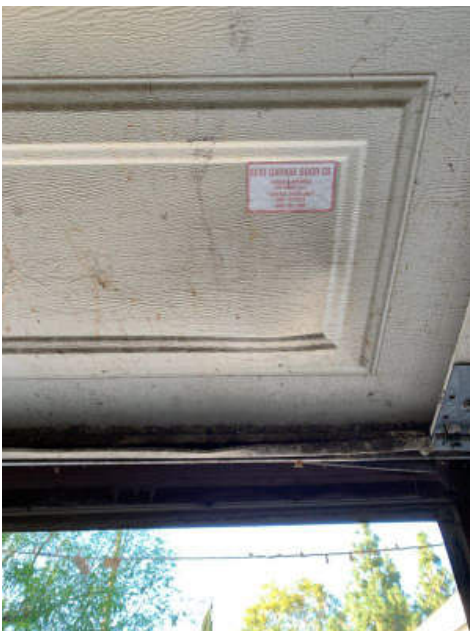
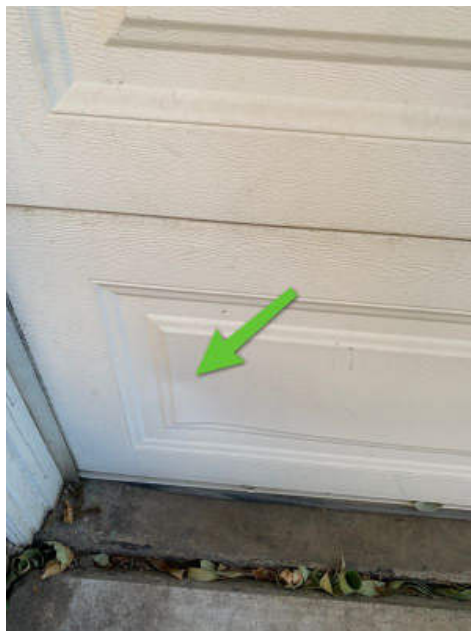
#### 8.4.1 Garage Door

##### **PANEL DAMAGE**

Garage door panel is damaged and may need repair/replacement. Recommend a qualified garage door contractor evaluate.

Contact a qualified garage door contractor.

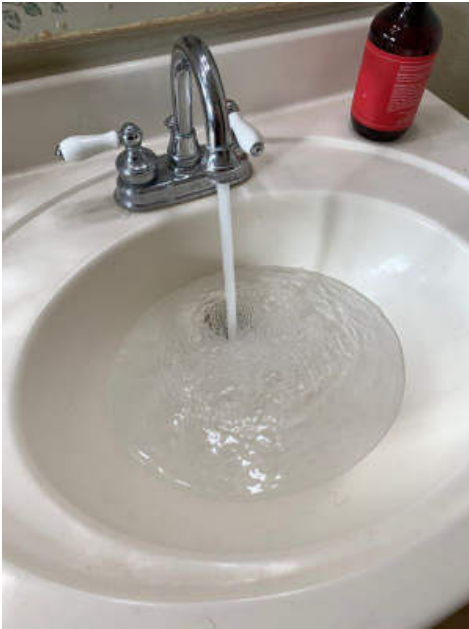
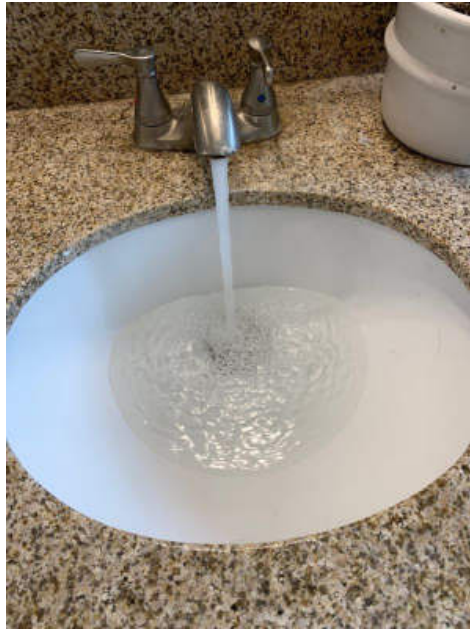
**Deficiencies****9.2.1 Drain, Waste, & Vent Systems****SINK - POOR DRAINAGE**

Sink(s) had slow/poor drainage. Recommend a qualified plumber repair.

Contact a qualified plumbing contractor.

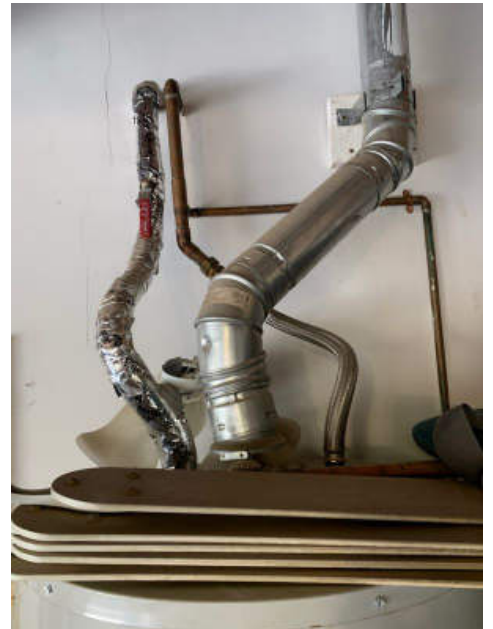
#### 9.4.1 Hot Water Systems, Controls, Flues & Vents

No expansion tank was present. Expansion tanks allow for the thermal expansion of water in the pipes. These are required in certain areas for new installs. Recommend a qualified plumber evaluate and install.

Contact a qualified plumbing contractor.

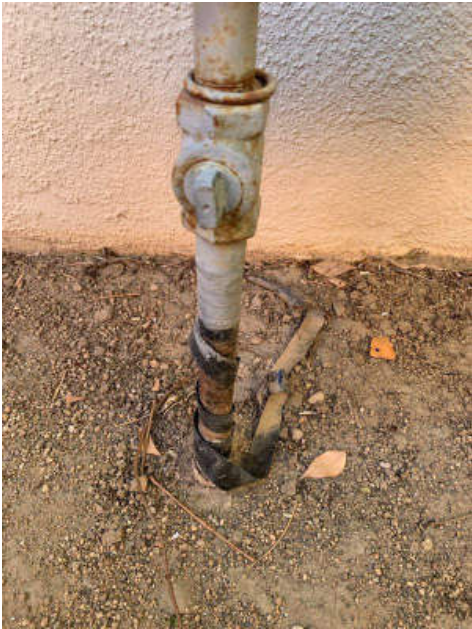
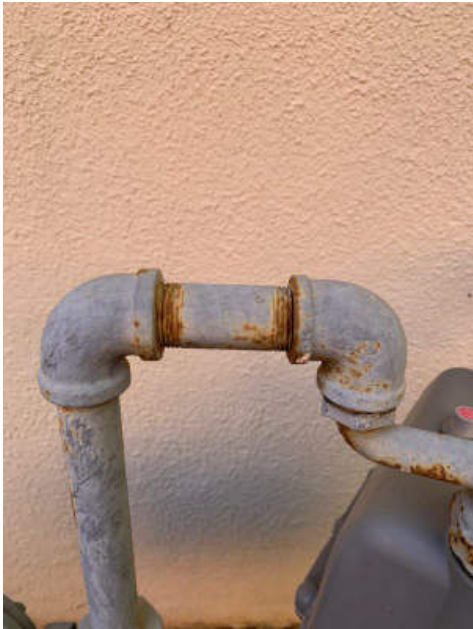
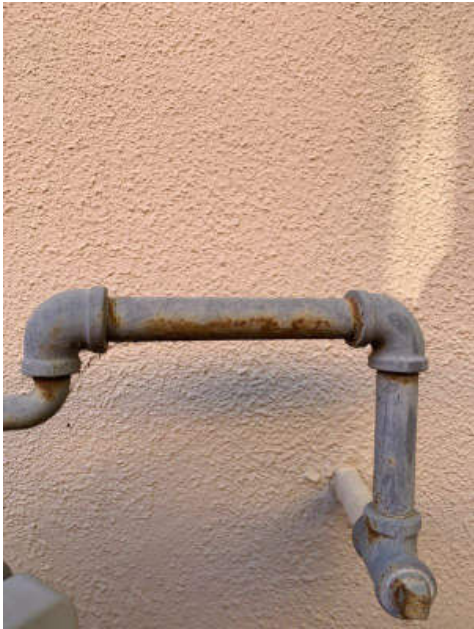
#### 9.5.1 Fuel Storage & Distribution Systems

##### **CORROSION**

Gas pipes were corroded. This can lead to gas leaks. Recommend contacting local utility company for evaluation and repair.

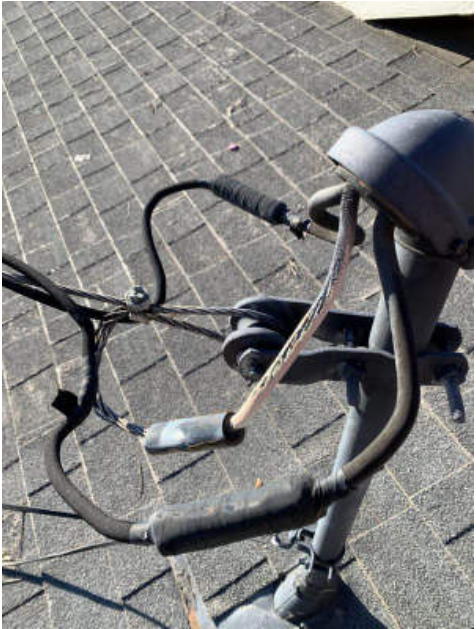
Wires on service entrance are damaged or frayed. Recommend contacting your electric utility company or a qualified electrician to evaluate and repair.

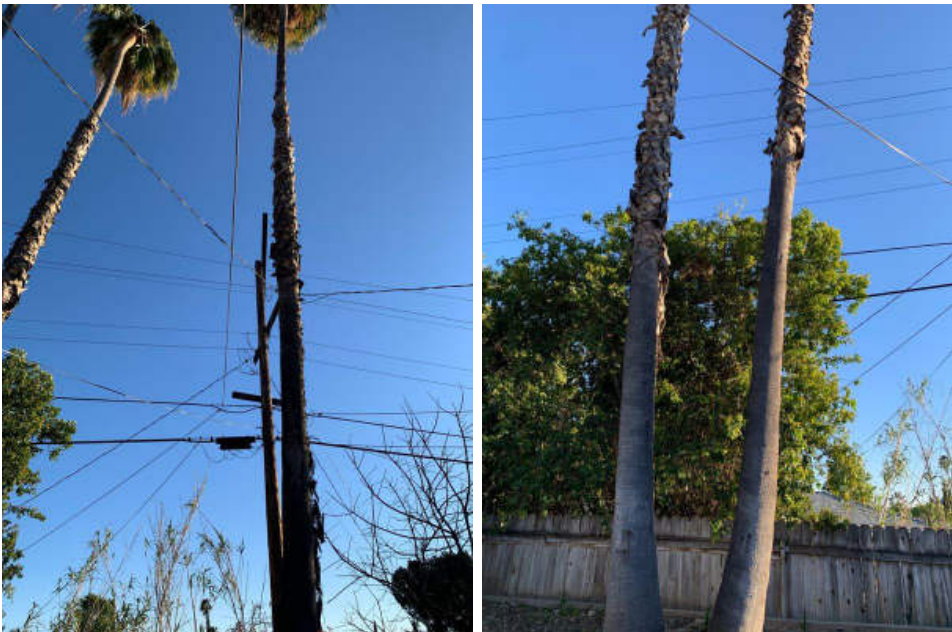
### 10.1.2 Service Entrance Conductors

#### SERVICE DROP VEGETATION CLEARANCE

At the time of the inspection the service drop passed through a hazardous location. It is recommended that power lines maintain 12ft of clearance from vegetation in all directions. Recommend consulting local utility company. **DO NOT ATTEMPT DIY.**

Recommendation  
Contact your local utility company  
Estimated Cost  
\$100 - \$1,000

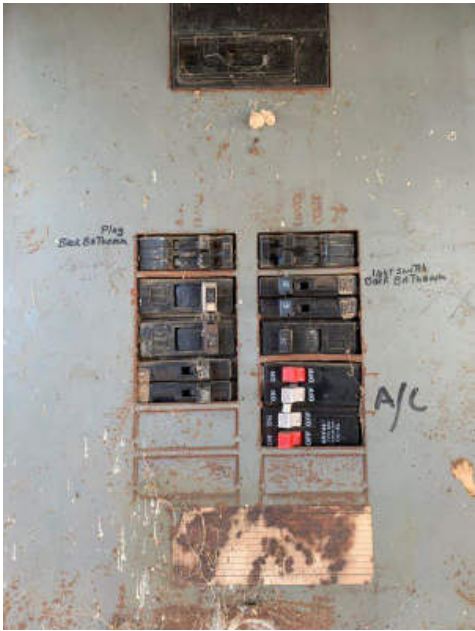
10.2.1 Main & Subpanels, Service & Grounding,  
Main Overcurrent Device

At the time of inspection, panel was missing labeling. Recommend a qualified electrician or person identify and map out locations.

Recommendation  
Contact a qualified electrical contractor.

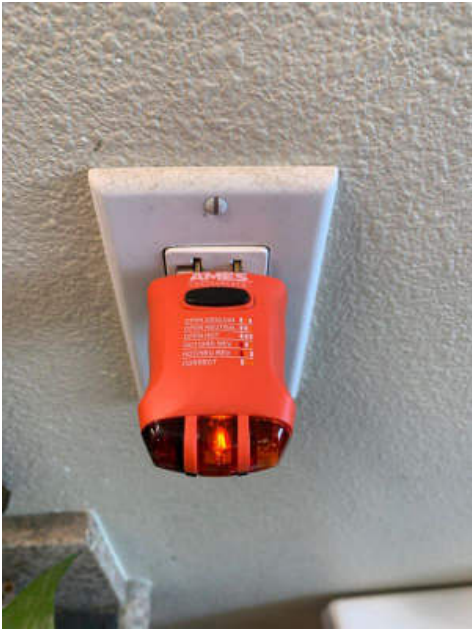
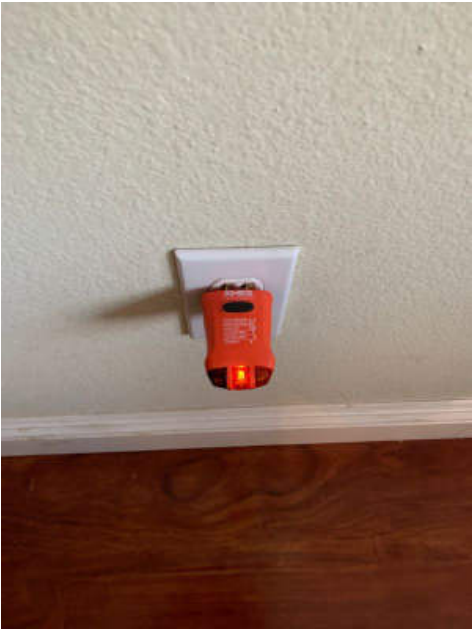
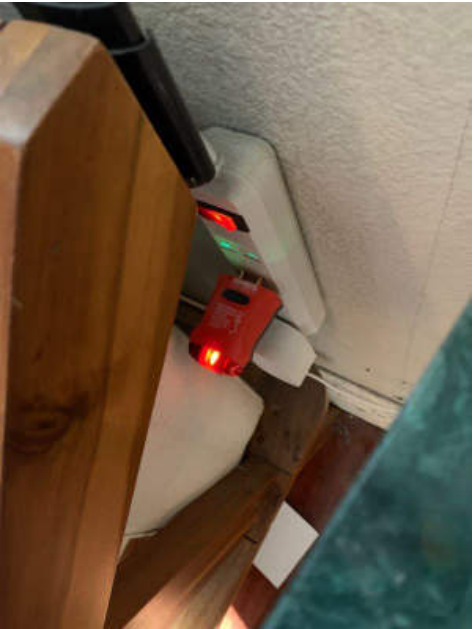
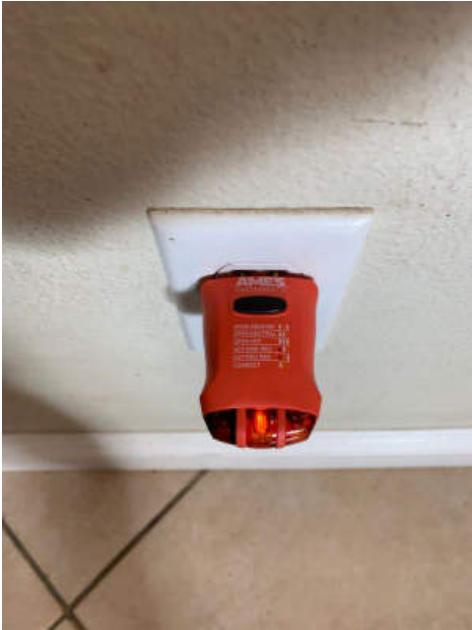
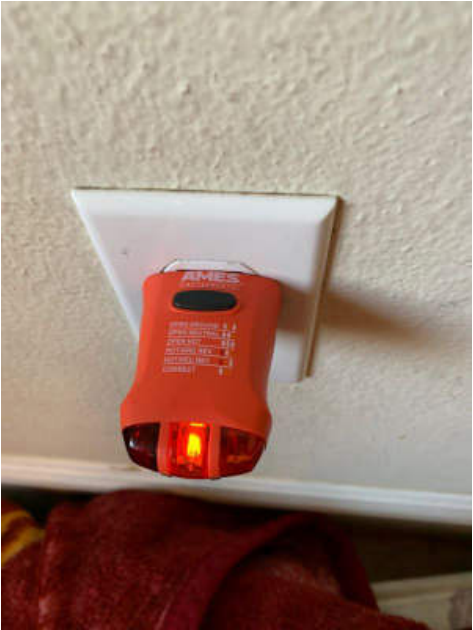
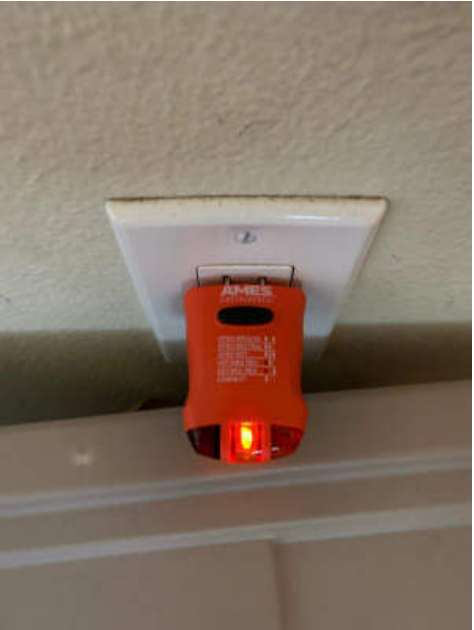
10.4.1 Lighting Fixtures, Switches & Receptacles

One or more receptacles were ungrounded. Recommend receptacles in kitchen, bathrooms, garage & exterior be grounded to minimize risk of electrical fire.

Recommendation  
Contact a qualified electrical contractor.
