WESTCO HOME INSPECTION, LLC

## RESIDENTIAL REPORT

1234 Main Street  
Riverside, CA 92507

09/29/2022 9:00AM

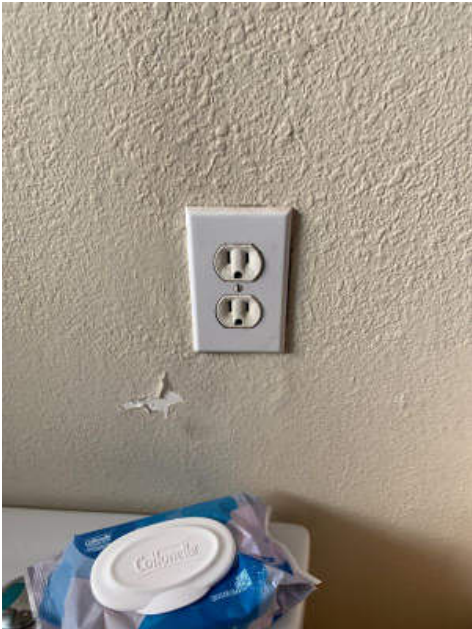
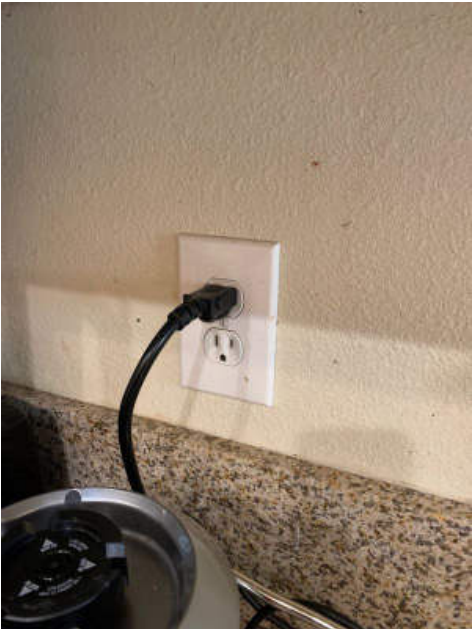
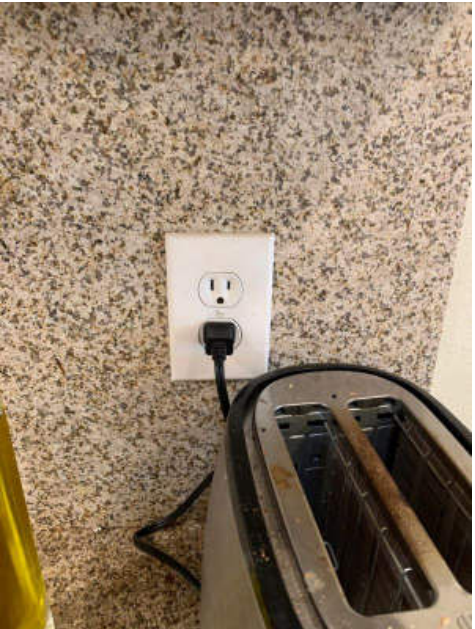
10.5.1 GFCI & AFCI

No GFCI protection was observed in some/all key locations. Recommend licensed electrician upgrade by installing ground fault receptacles in any location that has a higher risk of liquid exposure.

Recommendation  
Contact a qualified electrical contractor.

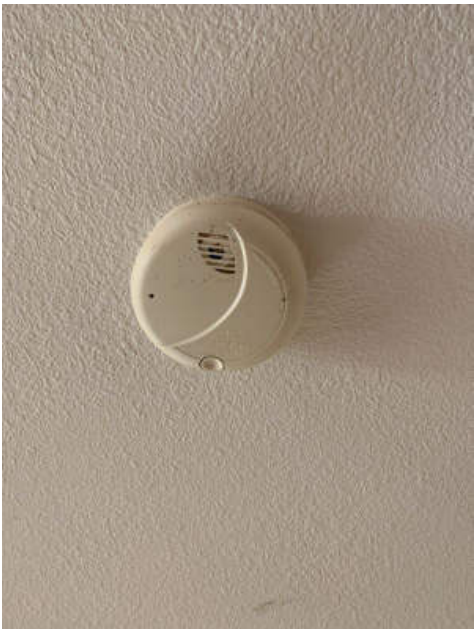
10.6.1 Smoke Detectors

Smoke detector was connected, but not functioning properly. Smoke detectors should be replaced every 10 years. Recommend replacement if defective.

Recommendation  
Recommended DIY Project

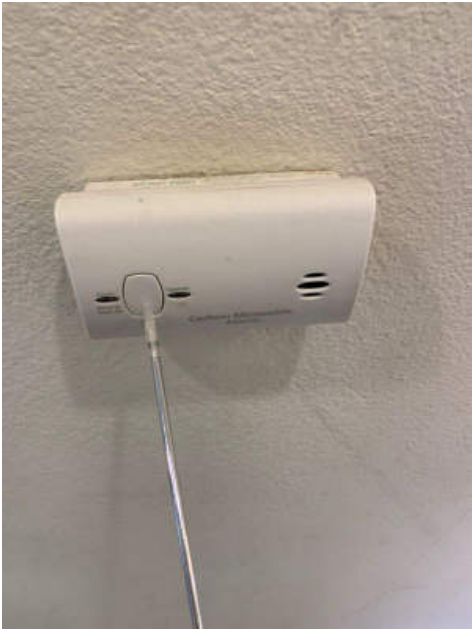
**POSSIBLY DEFECTIVE**

Carbon monoxide detector is connected, but not functioning properly. Carbon monoxide detectors should be replaced every 5 years. Recommend replacement if defective.

Recommendation  
Recommended DIY Project

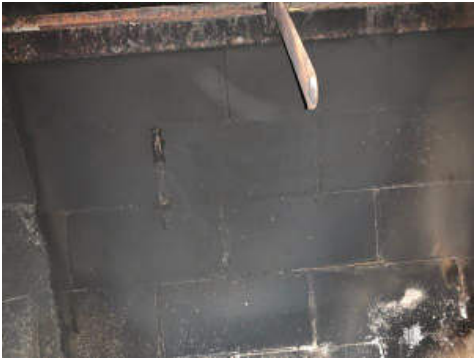
Chimney liner had layer of creosote dust, so underlying structure couldn't be inspected for cracks. Recommend qualified chimney sweep company inspect and/or clean.

Recommendation  
Contact a qualified chimney sweep.

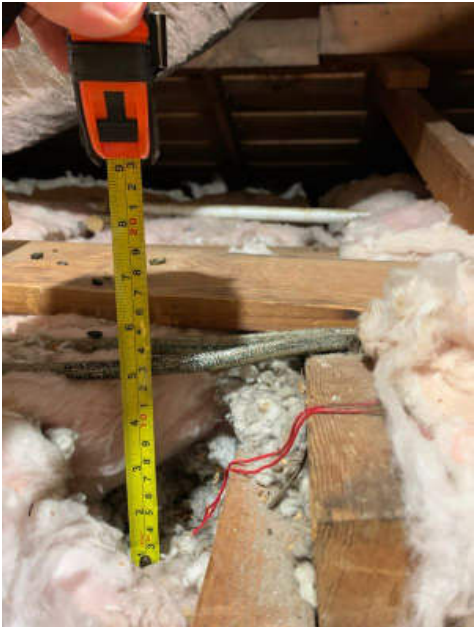
Insulation depth was inadequate. Recommend a qualified attic insulation contractor install additional insulation.

Contact a qualified professional.

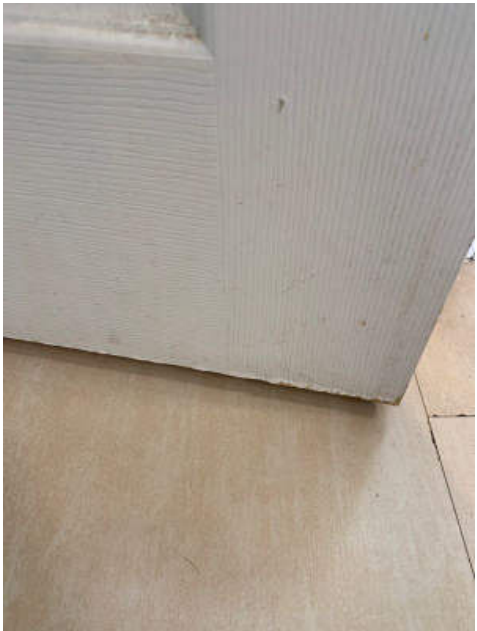
13.1.2 Doors

**WATER STAINING**

Door shows noticeable water staining, which could lead to further deterioration. Monitor for future repair or replacement.

Contact a qualified handyman.

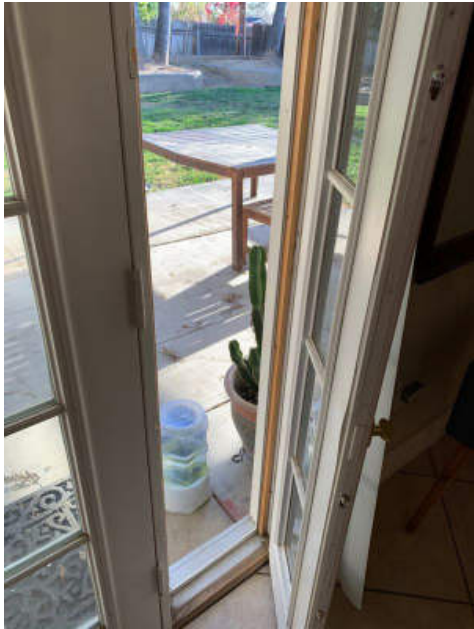
13.2.1 Windows

**MISSING SCREEN**

Window missing screen. Recommend replacement.

Contact a handyman or DIY project

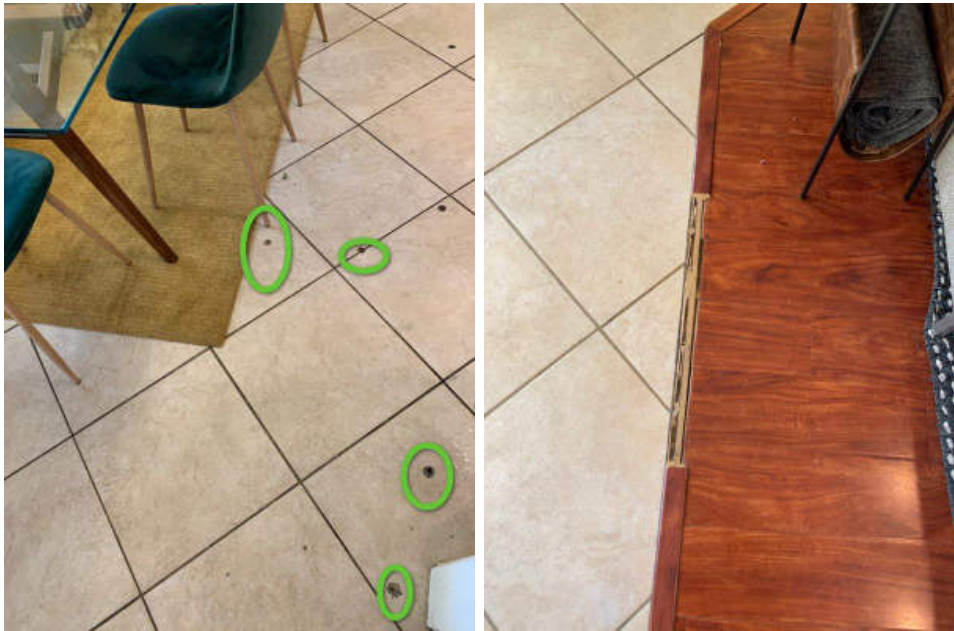
13.3.1 Floors

**DAMAGED (GENERAL)**

The home had general moderate damage visible at the time of the inspection. Recommend service by a qualified contractor.

Contact a qualified professional.

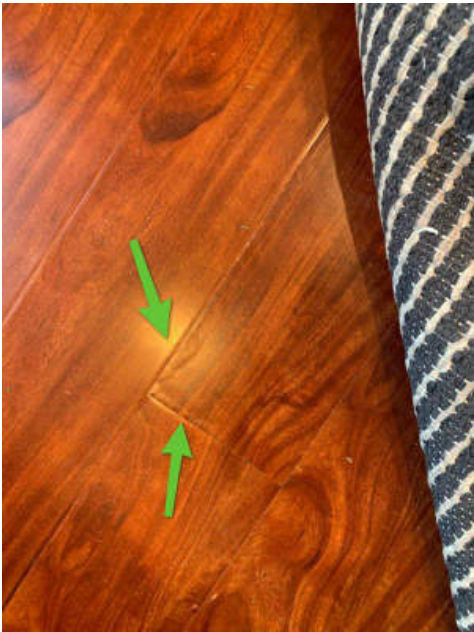
Floors had areas of visible moisture damage. Recommend a qualified flooring contractor evaluate & repair areas of moisture.

Recommendation  
Contact a qualified professional.

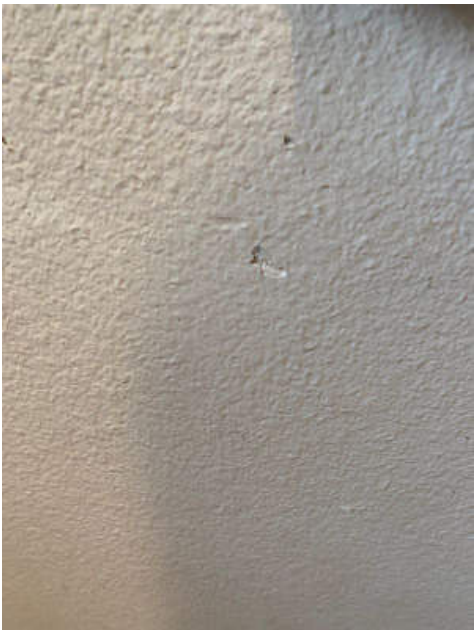
13.4.1 Walls

**DOORKNOB HOLE**

Wall had damage from doorknob. Recommend a qualified handyman or drywall contractor repair.

Recommendation  
Contact a handyman or DIY project

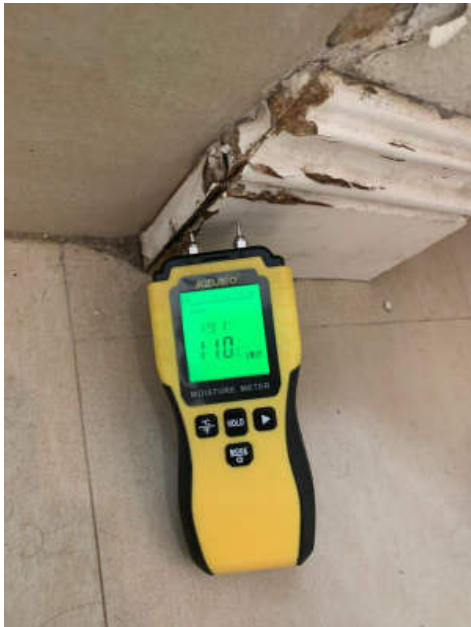
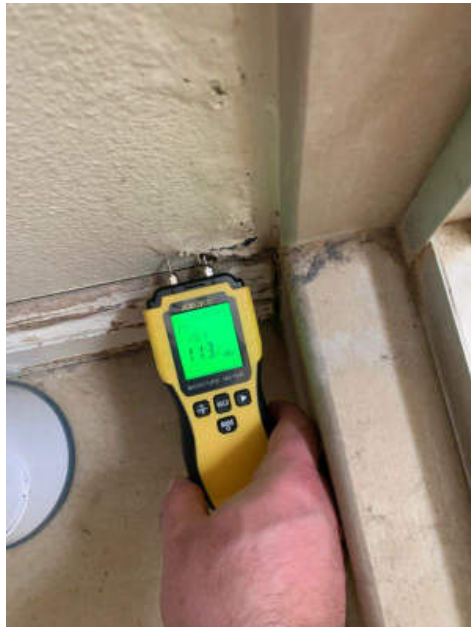
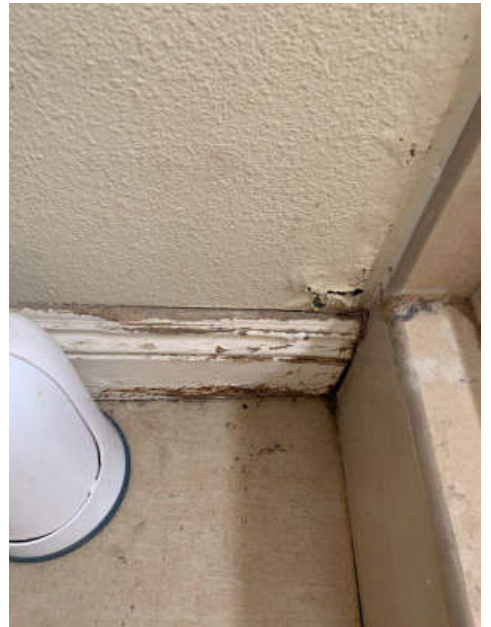
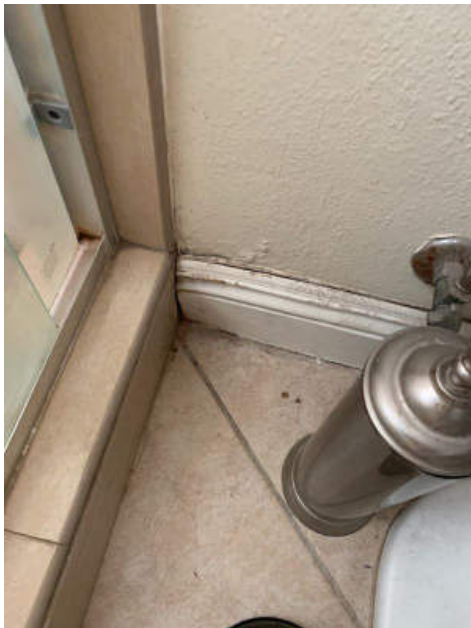
**MOISTURE DAMAGE**

Stains on the walls visible at the time of the inspection appeared to be the result of moisture intrusion. The source of moisture may have been corrected. Recommend further examination by a qualified contractor to provide confirmation.

Contact a qualified professional.

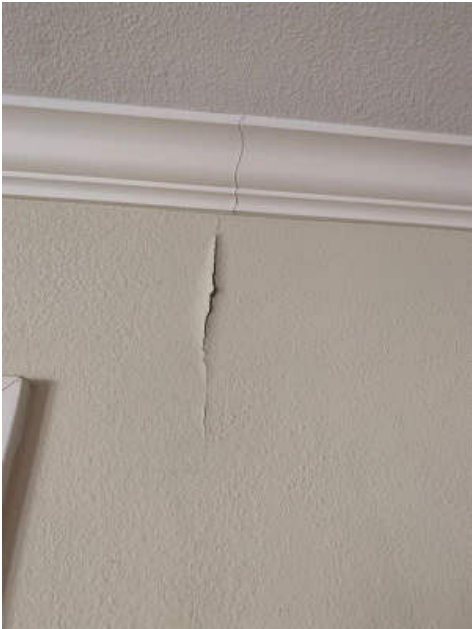
#### 13.4.3 Walls

### PAINT CRACKING

Wall paint was cracking in one or more areas. Recommend a qualified painter evaluate and apply a new coat.

Recommended DIY Project

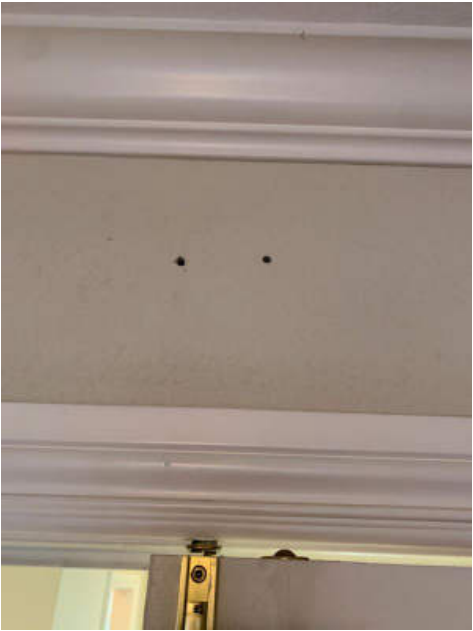
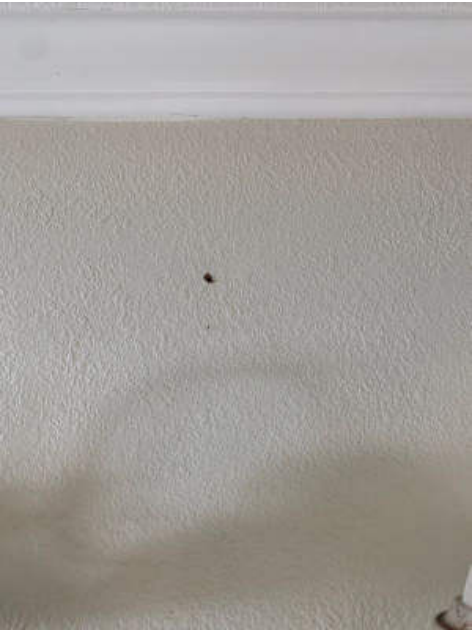
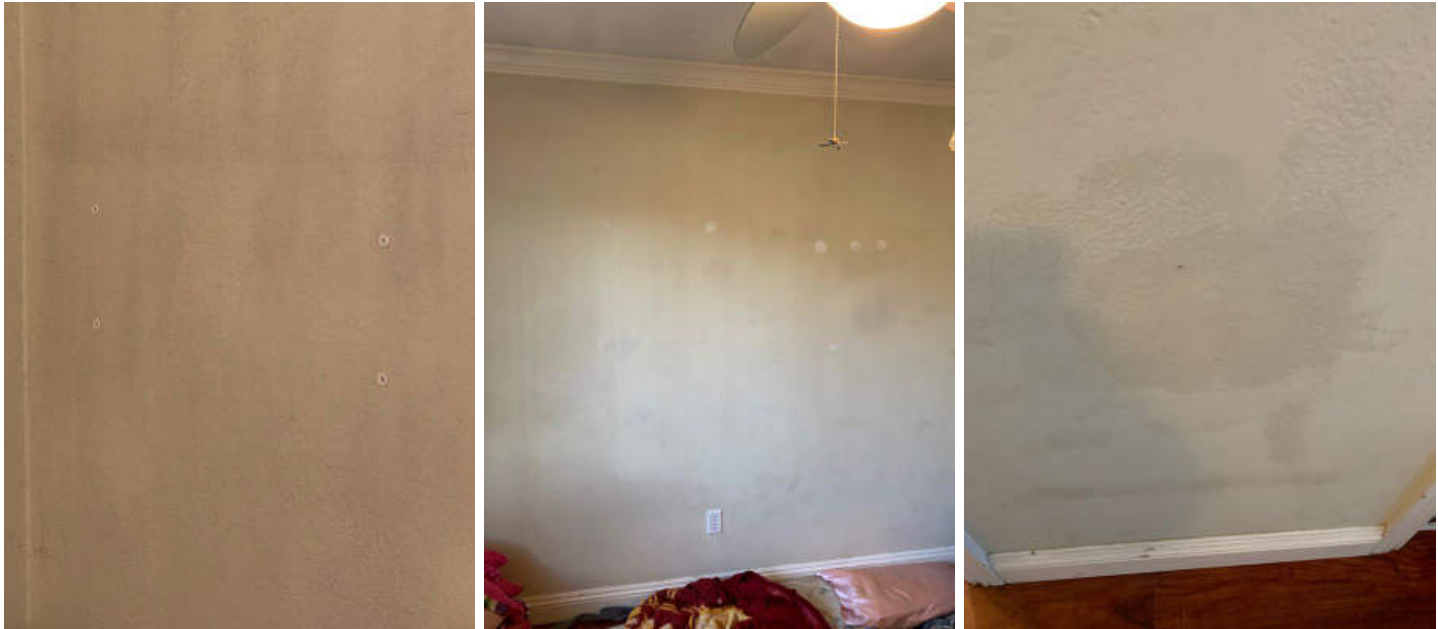
13.4.4 Walls

**POOR PATCHING**

Sub-standard drywall patching observed at time of inspection. Recommend re-patching.

Contact a handyman or DIY project

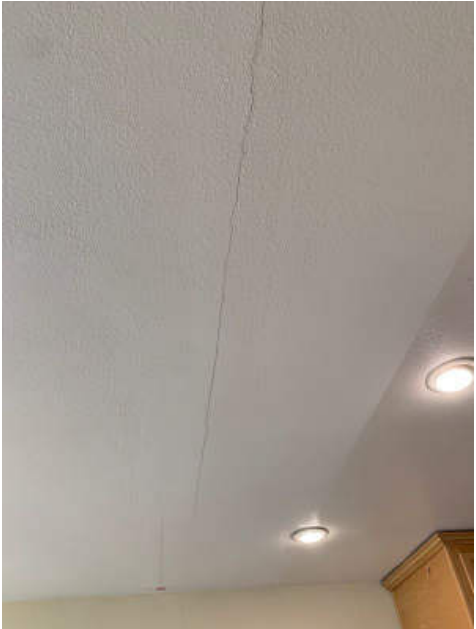
13.5.1 Ceilings

**MINOR DAMAGE**

Minor damage or deterioration to the ceiling was visible at the time of the inspection.

Contact a handyman or DIY project

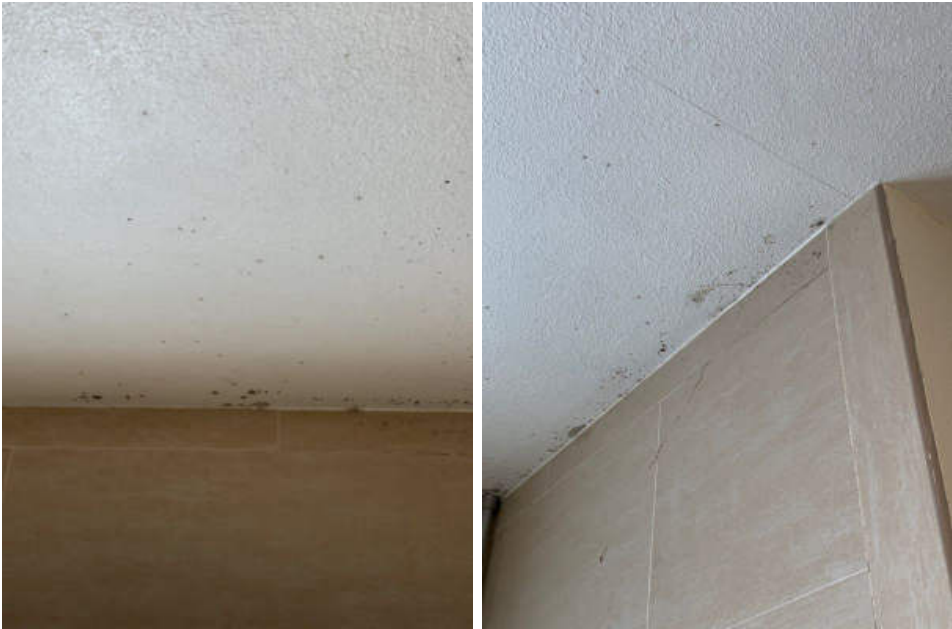
13.5.2 Ceilings

**POSSIBLE MOLD**

There are possible signs of fungi growth on ceiling. **It is unknown if this is a safety hazard.** Recommend a qualified mold inspector evaluate.

Contact a qualified mold inspection professional.

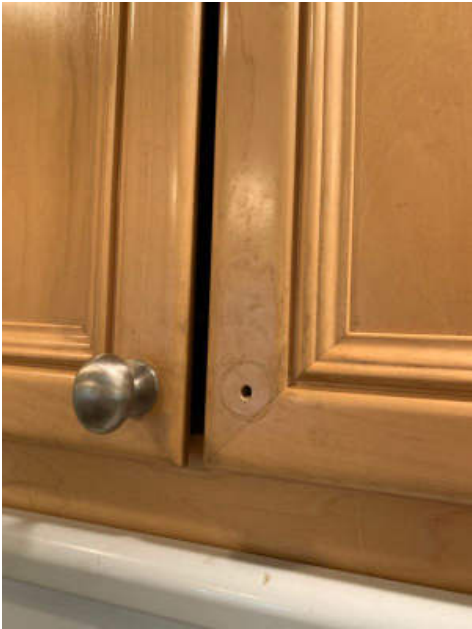
13.6.1 Countertops & Cabinets

**CABINET HANDLE MISSING**

One or more cabinet handles were missing.

Recommended DIY Project

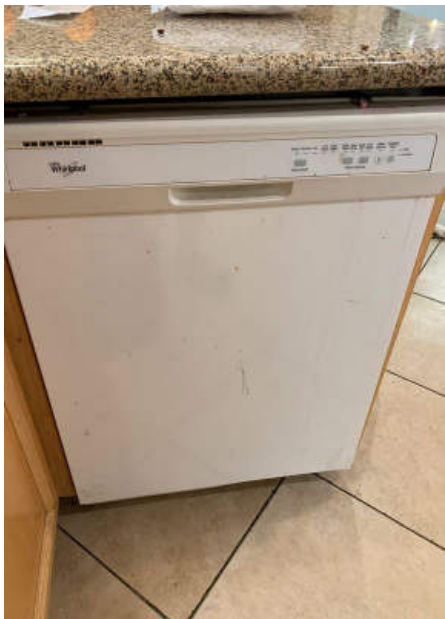
**Dishwasher: Brand**  
Whirlpool

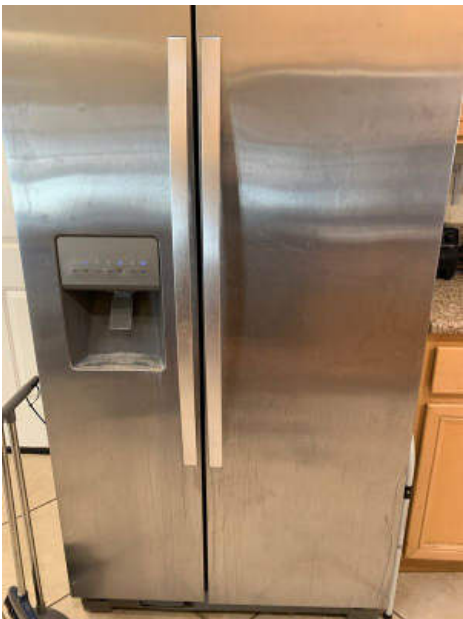
**Refrigerator: Brand**  
Whirlpool

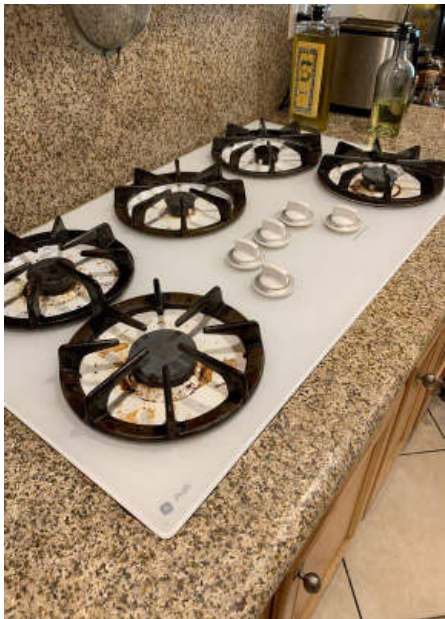
**Range/Oven/Cooktop:**  
**Range/Oven Brand**  
General Electric
