## SUMMARY

1234 Main Street Riverside CA 92507

Jeremy Gutierrez  
InterNACHI Certified Professional  
Inspector®  
WestCo Home Inspection, LLC  
(858) 333-4248  
[jg@wchinspection.com](mailto:jg@wchinspection.com)

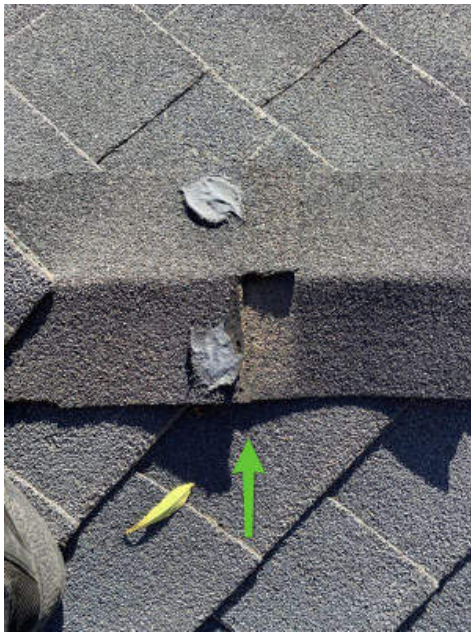
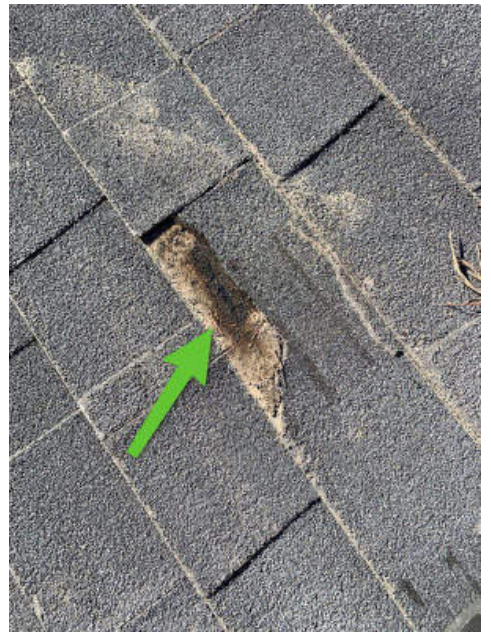
### 3.1.1 Coverings

#### DAMAGED (GENERAL)

Roof coverings showed moderate damage. Recommend a qualified roofing professional evaluate and repair.

Contact a qualified roofing professional.

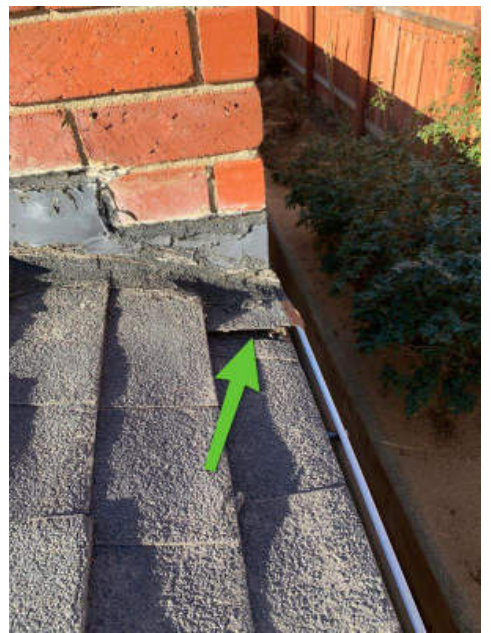
### 3.1.2 Coverings

## DELAMINATION

The asphalt shingle roof showed signs of delamination. Delamination is separation of the surface layer of asphalt. Recommend a qualified roofing contractor evaluate and repair to prevent further deterioration that results in leaking and moisture intrusion.

Contact a qualified roofing professional.

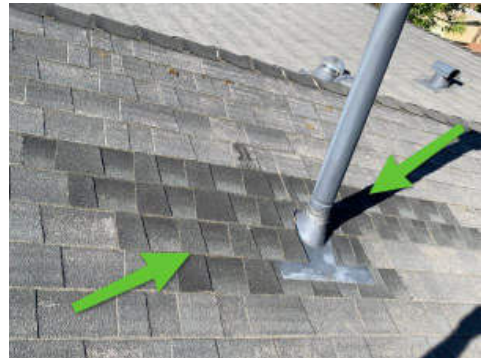
### 3.1.3 Coverings

## DISCOLORATION

Roof shingles were discolored, which can be caused by moisture, rust or soot. Recommend a qualified roofing contractor evaluate and remedy with a roof cleaning or repair.

Contact a qualified roofing professional.

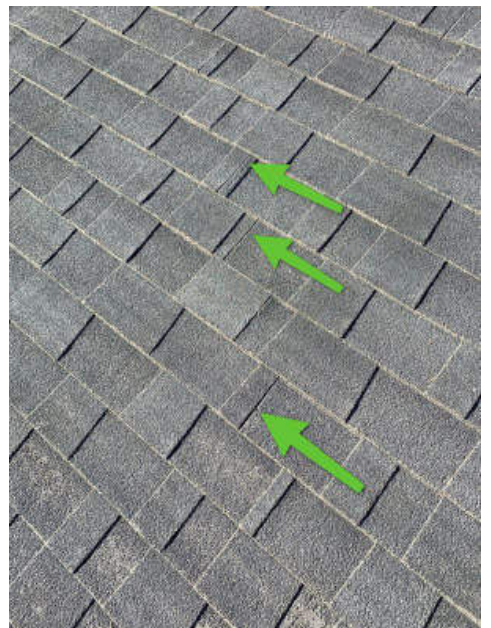
### 3.1.4 Coverings

## SPLITTING

The asphalt composition shingle roof had torn or split shingles which could lead to moisture intrusion. Recommend a qualified roofing contractor repair.

Contact a qualified roofing professional.

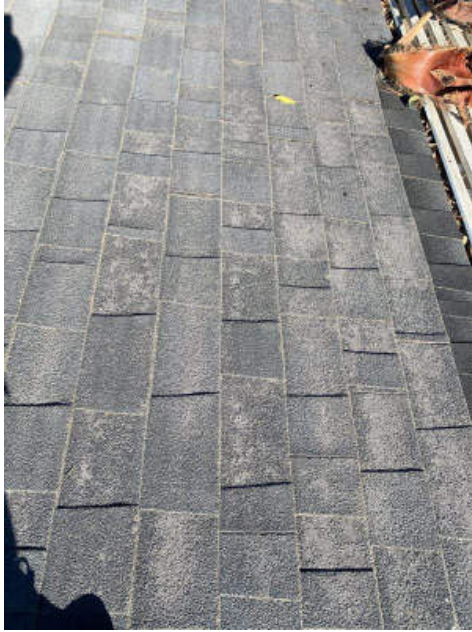
### 3.1.5 Coverings

## GRANULE DETERIORATION

Asphalt shingles are essentially a layer of tar coated with granules of rock that protect the surface. As a roof wears, the granules can come off the surface, weakening the shingle. At the time of the inspection some granules appeared to missing. Recommend a qualified professional come and further assess.

Contact a qualified roofing professional.

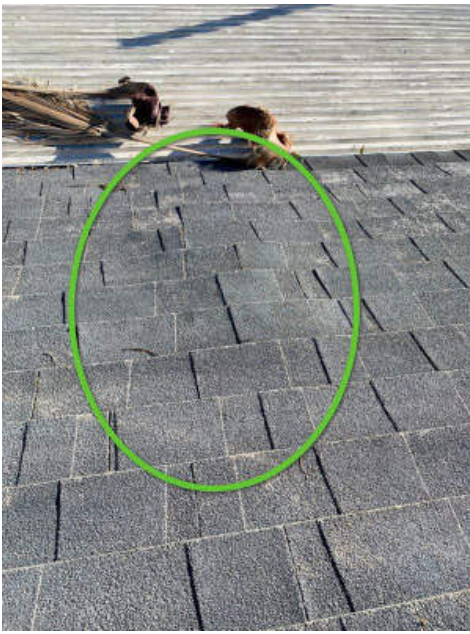
### 3.1.6 Coverings

#### **BUCKLED SHINGLES**

One or more sections of the roof were buckled at the time of the inspection. Moisture in the roof sheathing or felt paper can cause shingles to expand and buckle. This typically occurs when the sheathing is installed too tightly so it cannot expand and contract. It could also indicate poor attic ventilation. Recommend a qualified professional's further assessment.

Contact a qualified roofing professional.

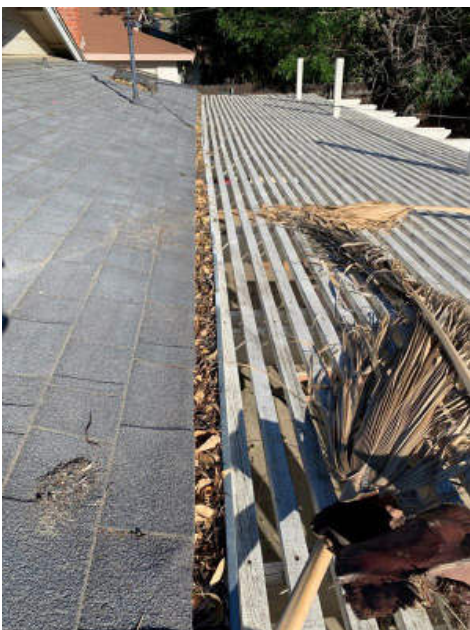
Debris had accumulated in the gutters. Recommend cleaning to facilitate water flow.

Recommended DIY Project

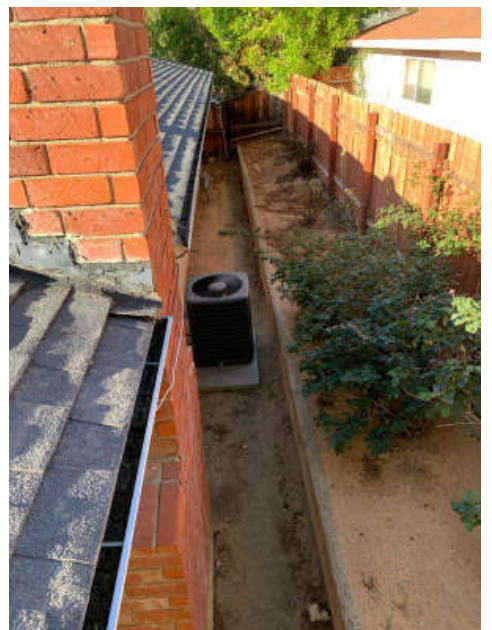
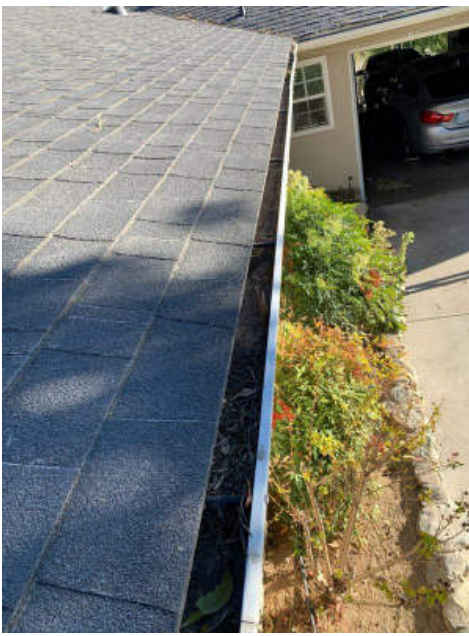
### 3.2.1 Roof Drainage Systems

## DEBRIS

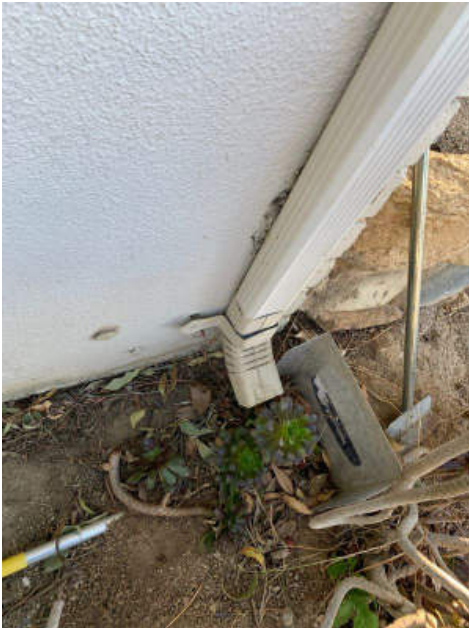
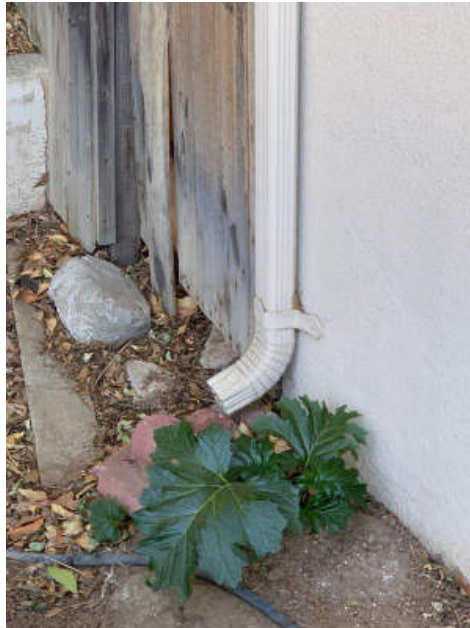
### 3.2.2 Roof Drainage Systems

One or more downspouts drained too close to the home's foundation. This can result in excessive moisture in the soil at the foundation, which can lead to foundation/structural movement. Recommend a qualified contractor adjust downspout extensions to drain at least 6 feet from the foundation.

Contact a handyman or DIY project

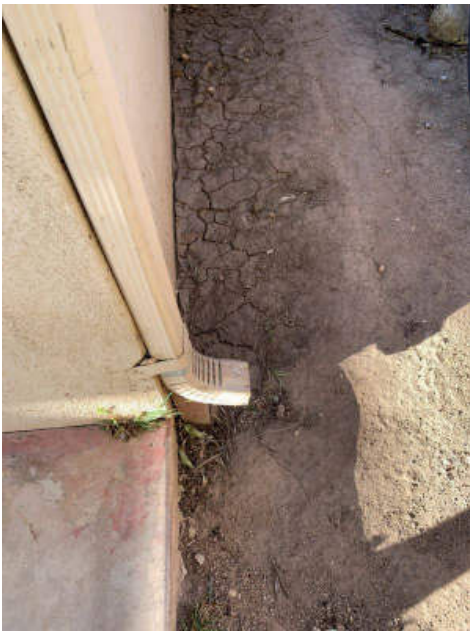
#### **DOWNSPOUTS DRAIN NEAR HOUSE**

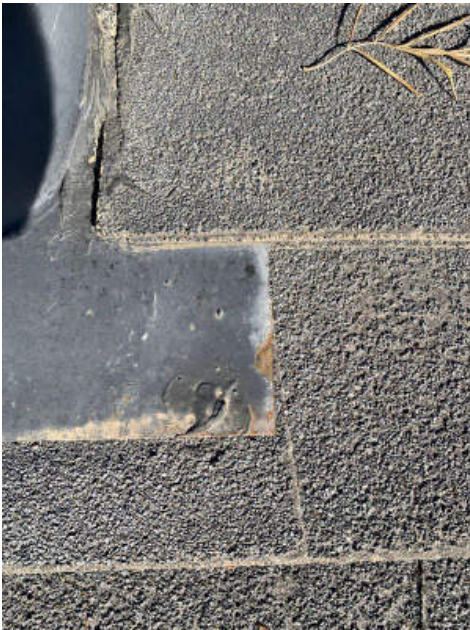
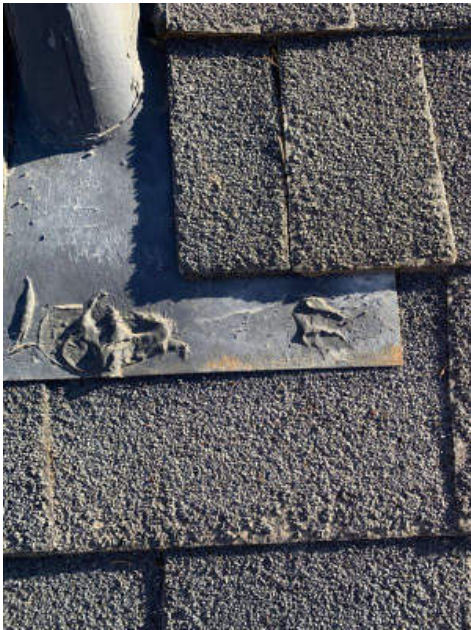
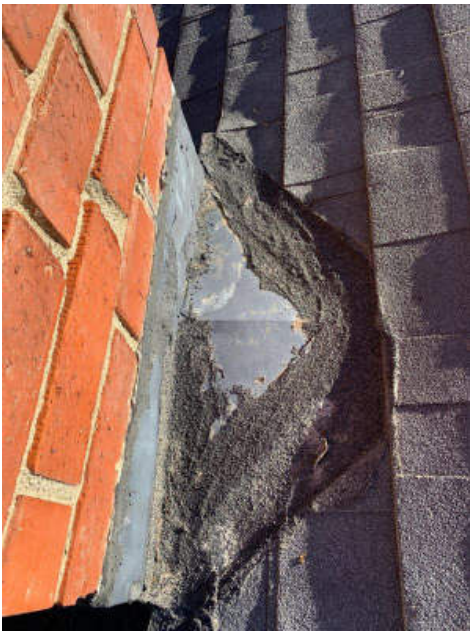
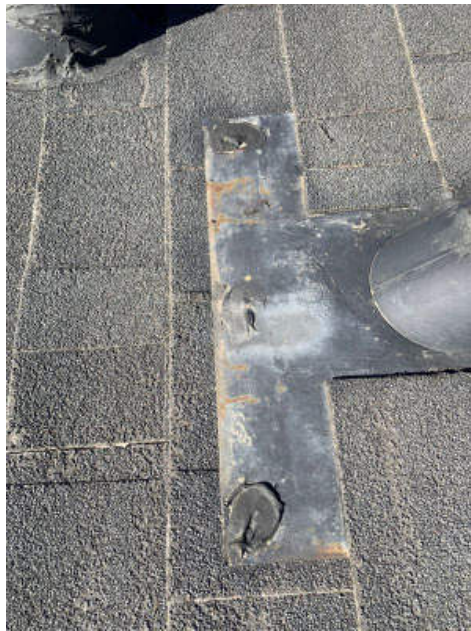
3.3.1 Flashings  
**CORRODED - MINOR**

Roof flashing showed signs of corrosion, but are still in working condition. Flashing should be monitored to prevent severe corrosion leading to moisture intrusion.

Recommendation  
Recommend monitoring.

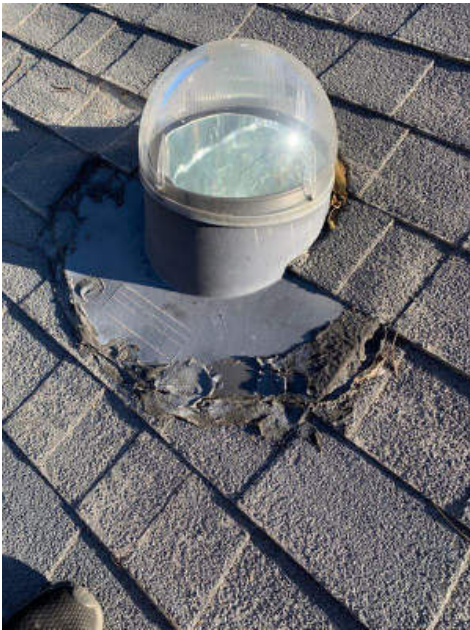
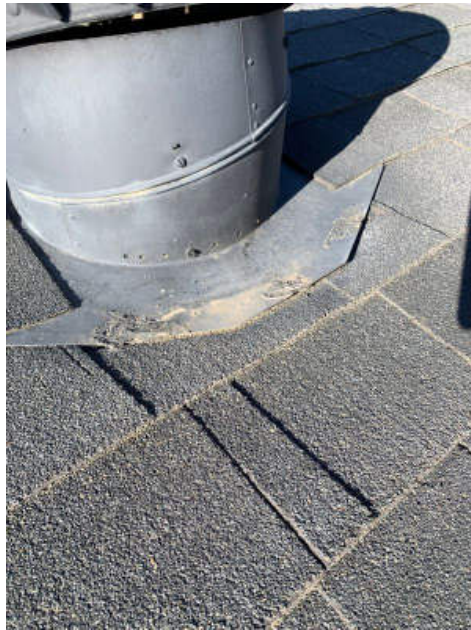
3.3.2 Flashings  
**LOOSE/SEPARATED**

Flashings observed to be loose or separated, which can lead to water intrusion and/or mold. Recommend a qualified roofing contractor repair.

Recommendation  
Contact a qualified roofing professional.

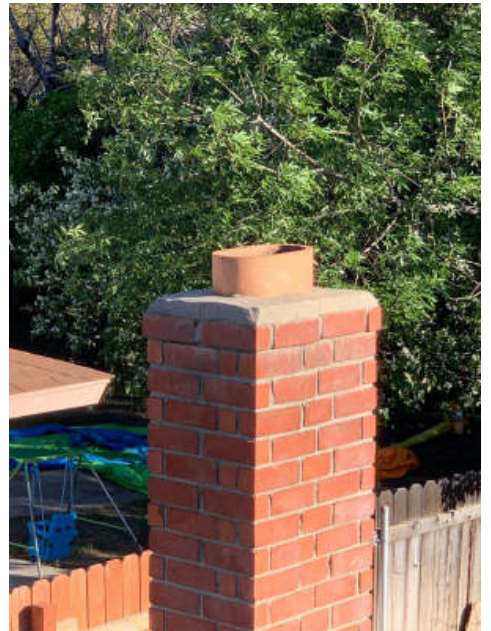
##### **CHIMNEY CAP MISSING**

No chimney cap was observed. This is important to protect from moisture intrusion and protect the chimney. Recommend installation.

Maintenance Item

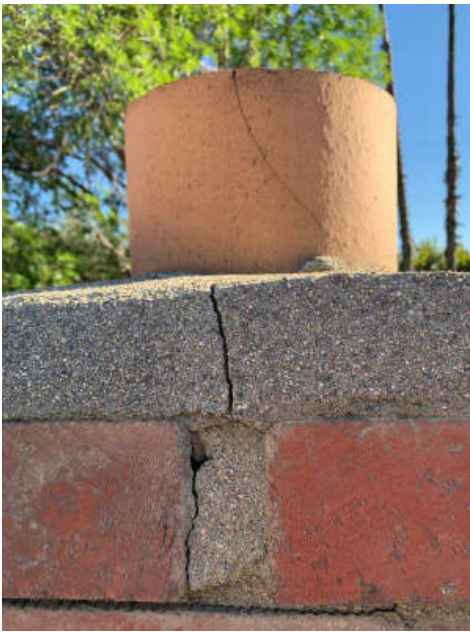
#### 3.4.2 Skylights, Chimneys & Other Roof Penetrations

##### **CHIMNEY FLUE CRACKED - MINOR**

The chimney flue had one or more cracks, which can lead to further damage to the chimney structure. Recommend repair.

Maintenance Item

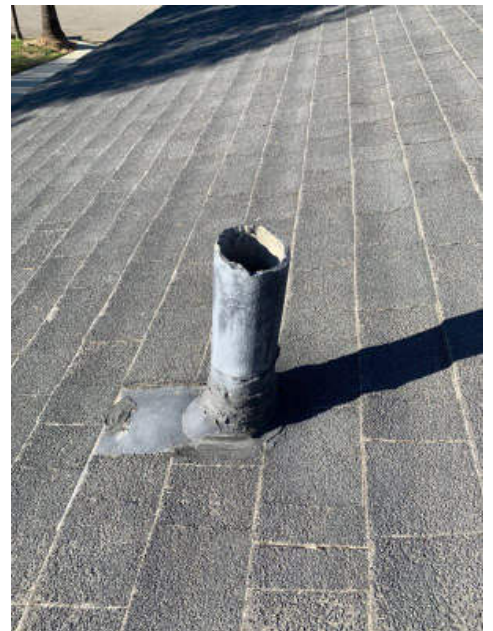
### 3.4.3 Skylights, Chimneys & Other Roof Penetrations

#### FLUE/VENT DAMAGED

One or more of the flues/vents showed signs of damaged at the time of the inspection. Recommend repair.

Contact a qualified professional.

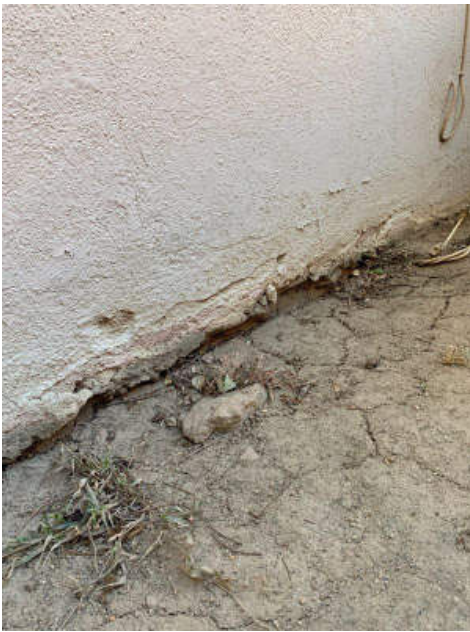
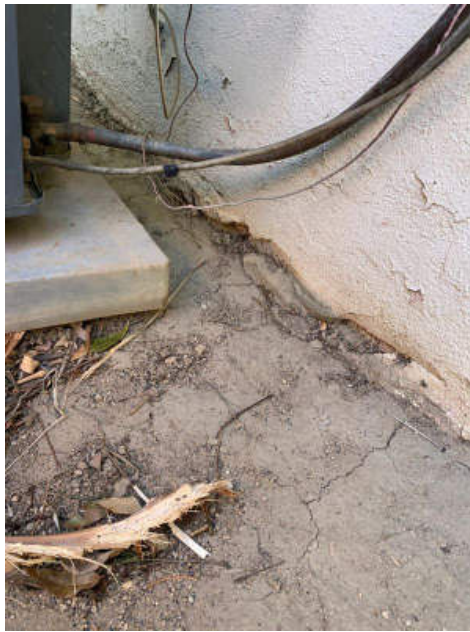
#### DETERIORATION - MAJOR

Moderate to major deterioration was observed at one or more points on the exterior. Recommend consulting with a stucco expert.

Recommendation

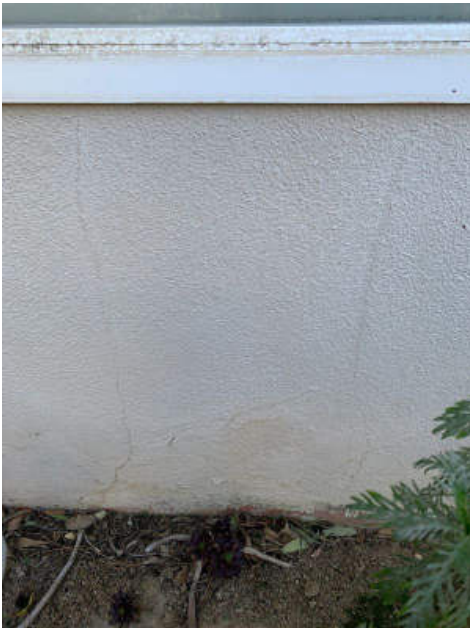
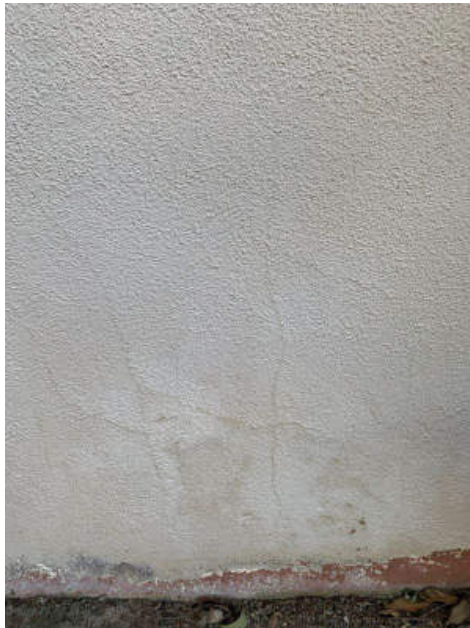
#### 4.1.2 Siding, Flashing & Trim

##### **CRACKING - MINOR**

Siding showed cracking in one or more places. This is a result of temperature changes, and typical as homes with stucco age. Recommend monitoring.

Recommend monitoring.

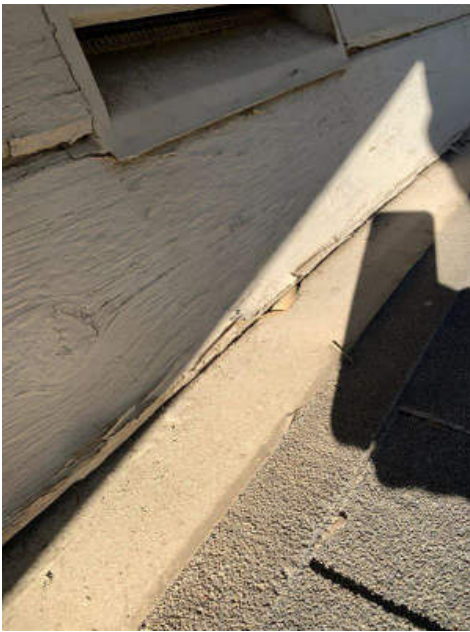
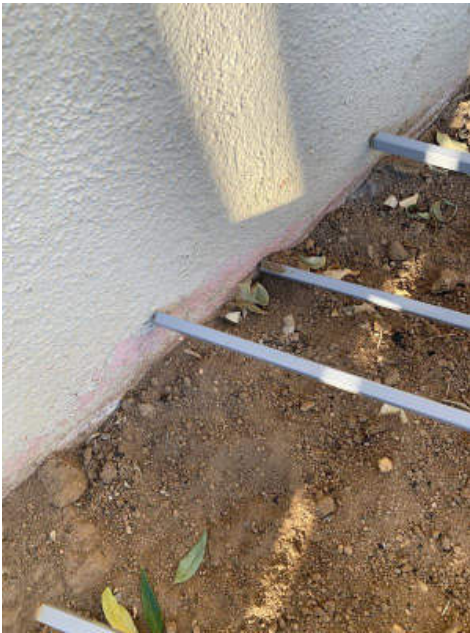
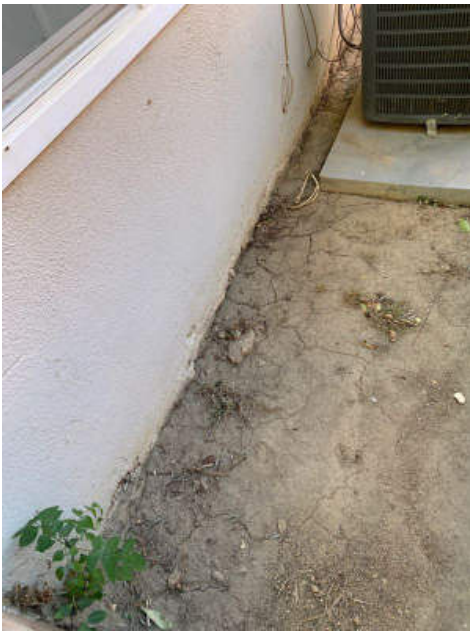
#### 4.1.3 Siding, Flashing & Trim

##### **EVIDENCE OF WATER INTRUSION**

Siding showed signs of water intrusion. This could lead to further siding deterioration and/or mold. Recommend a qualified siding contractor evaluate and repair.

Contact a qualified siding specialist.

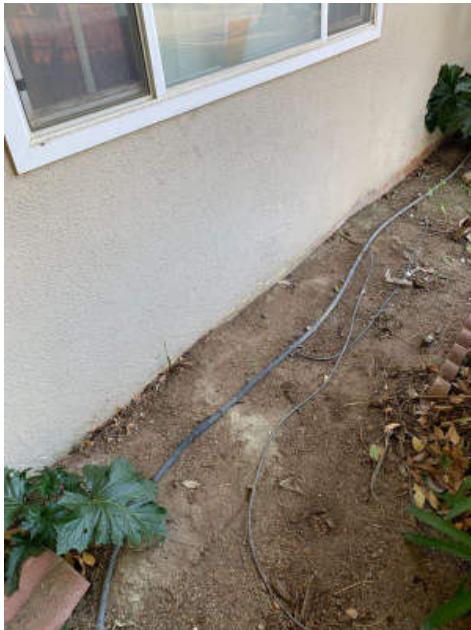
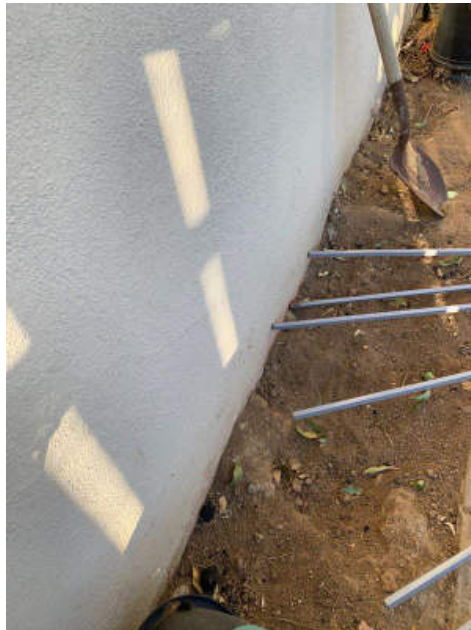
#### 4.1.4 Siding, Flashing & Trim

### GROUND CLEARANCE

Inadequate clearance between siding and ground was observed. Recommend a minimum ground clearance between bottom of siding and ground of 4".

Recommend monitoring.

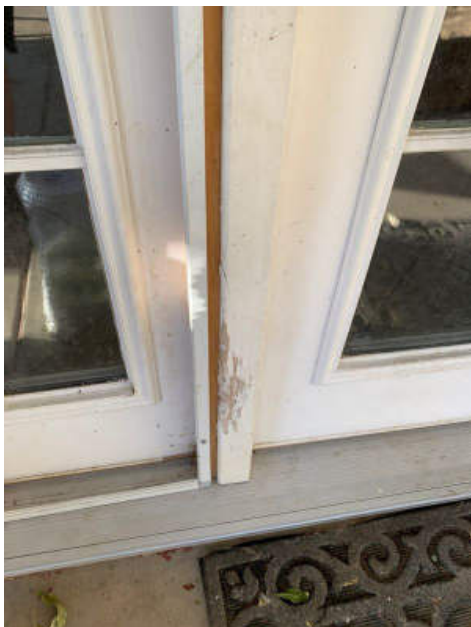
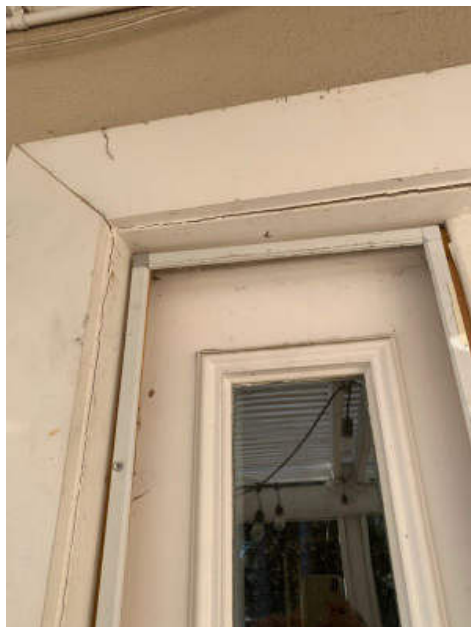
#### 4.2.1 Exterior Doors

### DOOR SILL/TRIM

Door sill and/or trim was loose, deteriorated or worn and repair or replacement should be considered.

Contact a handyman or DIY project

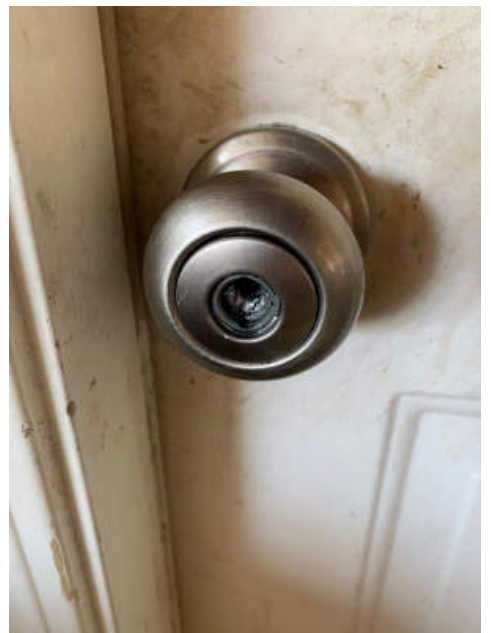
#### 4.2.2 Exterior Doors

### HARDWARE DAMAGED

One or more pieces of door hardware were damaged. Recommend repair or replace.

Recommendation  
Recommended DIY Project

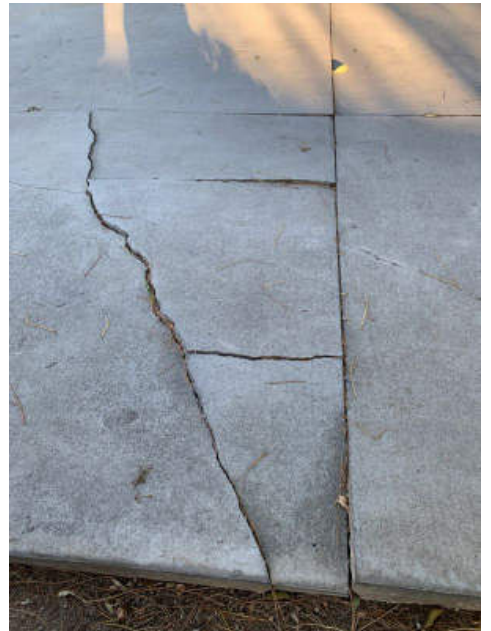
#### 4.3.1 Walkways, Patios & Driveways

### DRIVEWAY CRACKING - MAJOR

Major cracks observed. Recommend concrete contractor evaluate and replace.

Recommendation  
Contact a qualified concrete contractor.

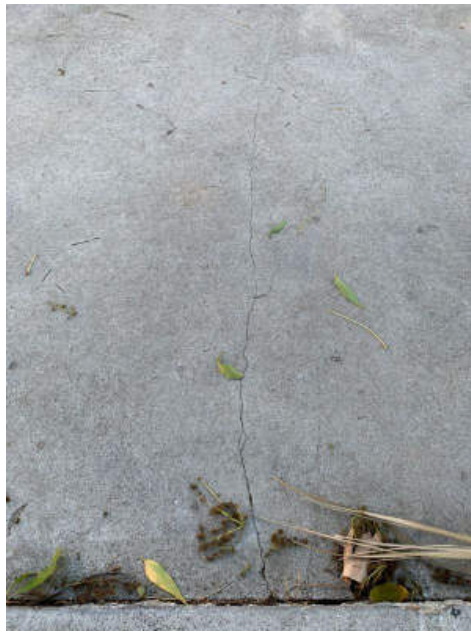
#### 4.3.2 Walkways, Patios & Driveways

### DRIVEWAY CRACKING - MINOR

Minor cosmetic cracks observed, which may indicate movement in the soil. Recommend monitor and/or have concrete contractor patch/seal.

Recommendation  
Recommend monitoring.

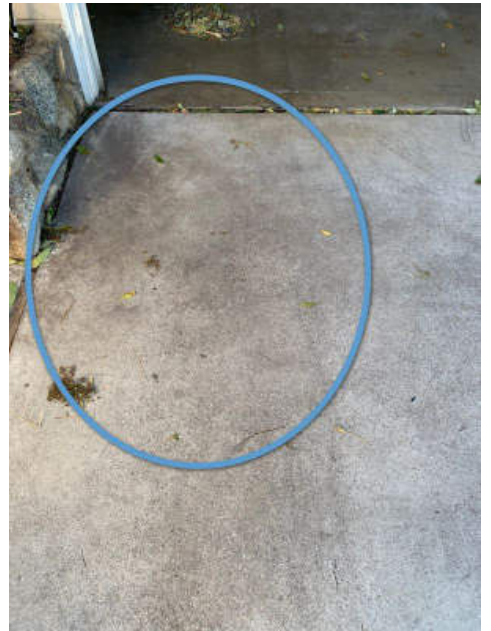
#### 4.3.3 Walkways, Patios & Driveways

##### **DRIVEWAY DRAINING TOWARDS HOME**

The driveway had a negative slope and drained towards the structure. Recommend a driveway contractor evaluate and repair.

Contact a qualified driveway contractor.

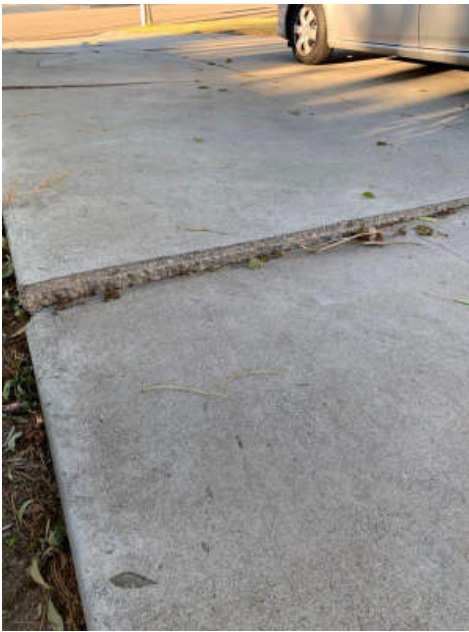
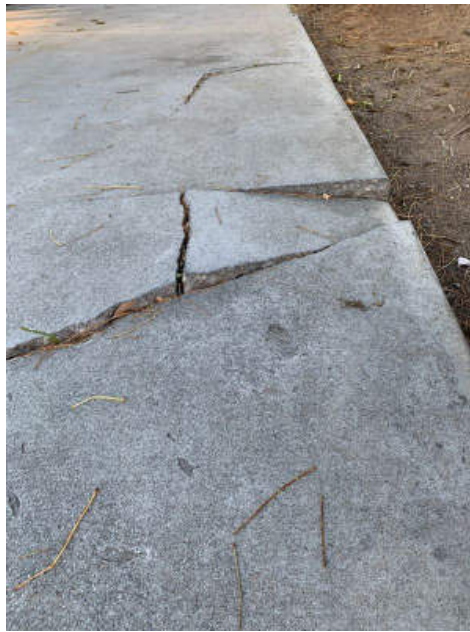
##### **DRIVEWAY TRIP HAZARD**

Trip hazards observed. These hazards also pose a liability risk. Patch or repair recommended.

Contact a qualified concrete contractor.

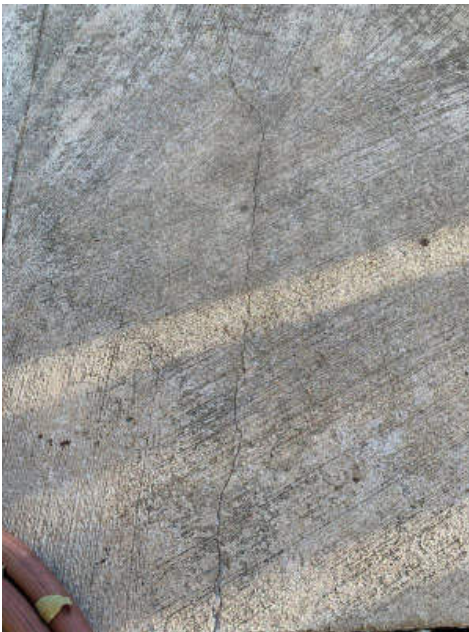
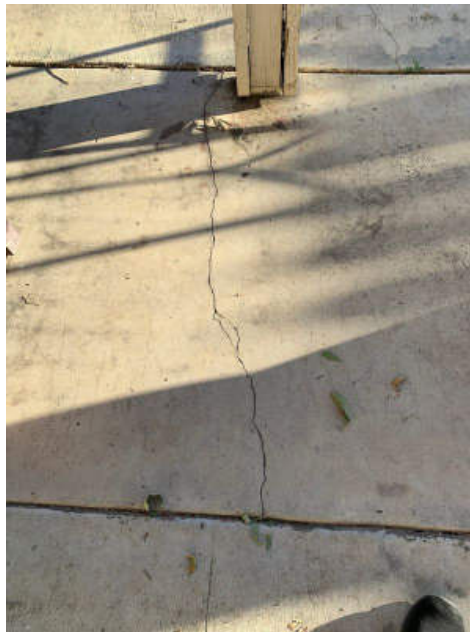
#### 4.3.5 Walkways, Patios & Driveways

### **PATIO CRACKING - MINOR**

Normal settling & cracking observed. Recommend monitor and/or patch/seal.

Recommend monitoring.

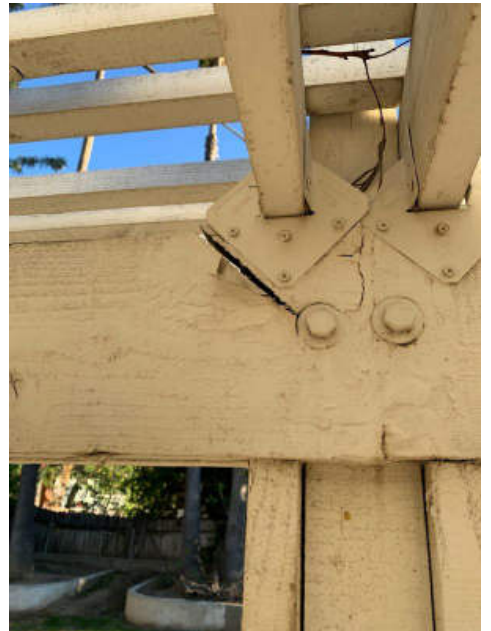
#### 4.4.1 Decks, Balconies, Porches & Steps

##### **PERGOLA - DAMAGED BEAM**

One or more of the pergola beams showed signs of damage. Recommend a qualified professional repair.

Contact a qualified professional.

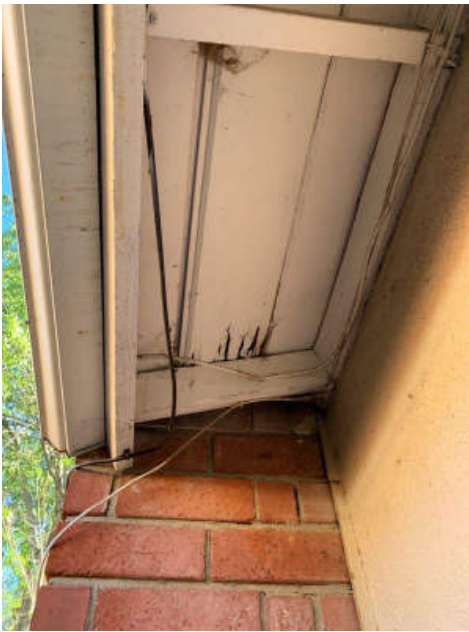
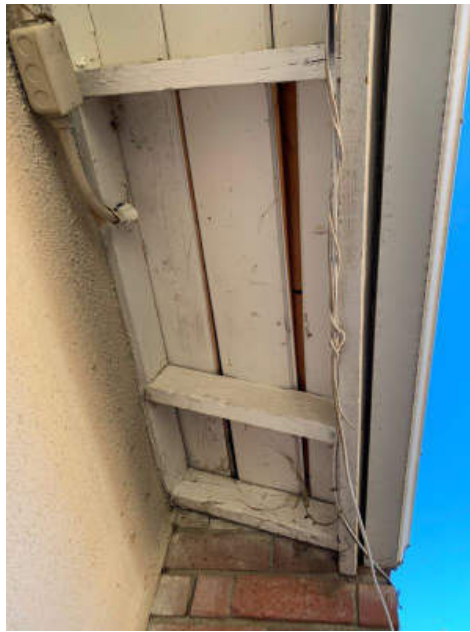
##### **EAVES - DAMAGED**

One or more sections of the eaves were damaged. Recommend qualified roofer evaluate & repair.

Contact a qualified roofing professional.

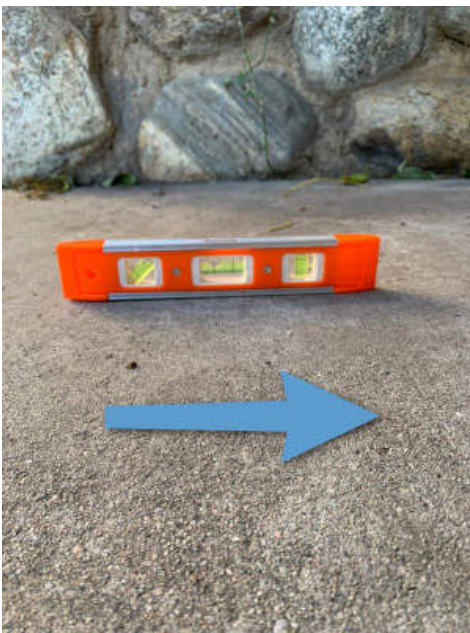
Grading was sloping towards the home in some areas. This could lead to water intrusion and foundation issues. Recommend qualified landscaper or foundation contractor regrade so water flows away from home.

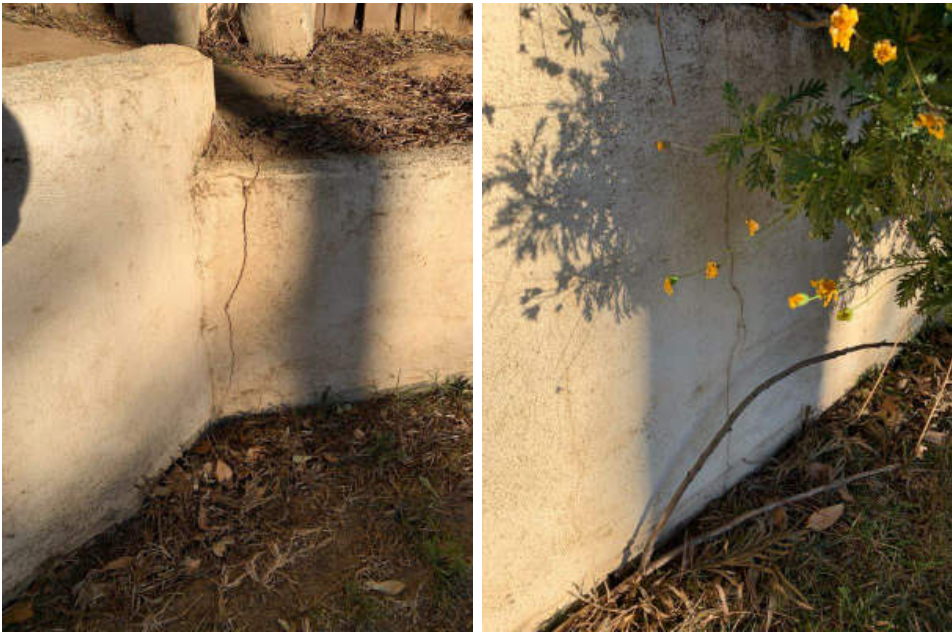
4.6.2 Vegetation, Grading, Drainage & Retaining Walls

**RETAINING WALL CRACKS**

Retaining wall was showing signs of failing. Recommend monitoring or repair.

Recommendation  
Recommend monitoring.

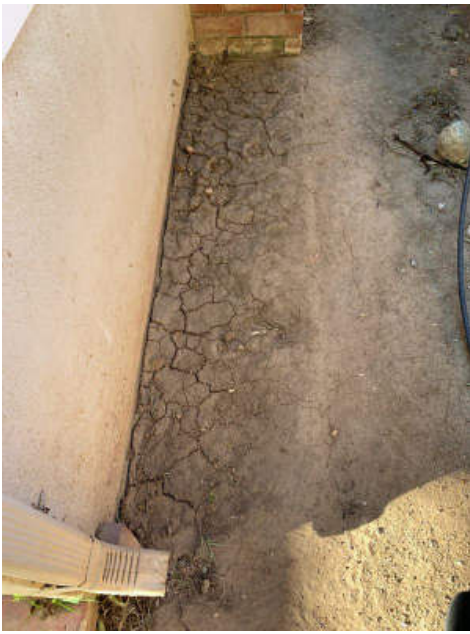
4.6.3 Vegetation, Grading, Drainage & Retaining Walls

**STANDING WATER**

Standing water observed, which could indicate poor drainage and/or grading. Recommend monitor and/or have landscaper correct.

Recommendation  
Contact a qualified landscaping contractor

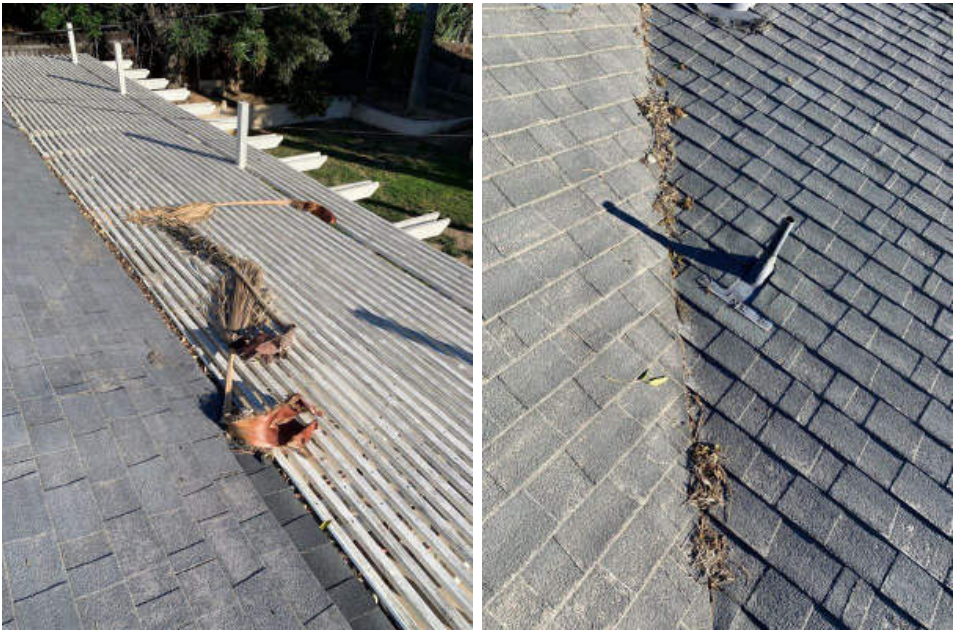
4.6.4 Vegetation, Grading, Drainage & Retaining Walls

**TREE DEBRIS ON ROOF**

Tree debris observed on roof. This can cause improper drainage to gutters and downspouts. Recommend clearing debris.

Recommendation  
Contact a handyman or DIY project

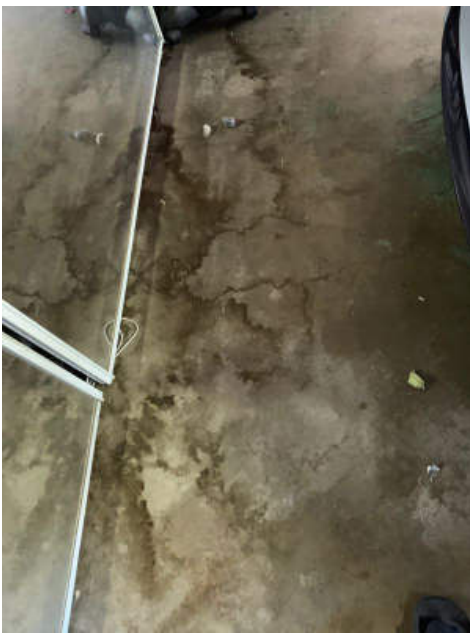
### 8.2.3 Floor **STAINING**

Garage floor showed visible staining from oil/grease. Recommend scrubbing with a degreaser or cleaning solution.

Recommendation  
Recommended DIY Project

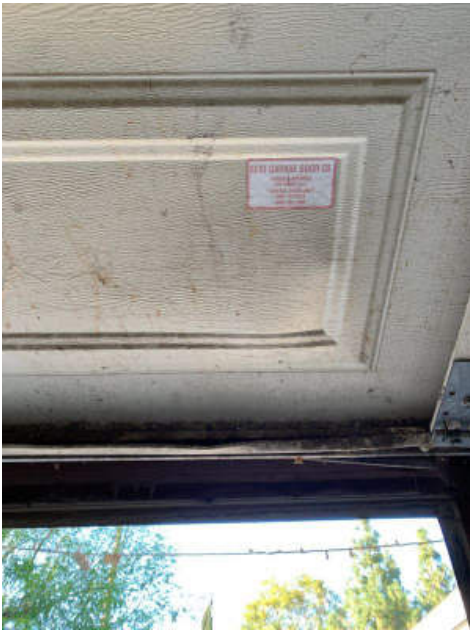
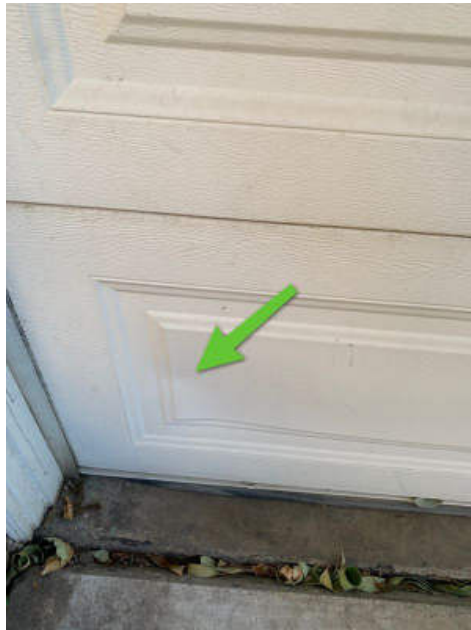
Garage door panel is damaged and may need repair/replacement. Recommend a qualified garage door contractor evaluate.

Recommendation  
Contact a qualified garage door contractor.

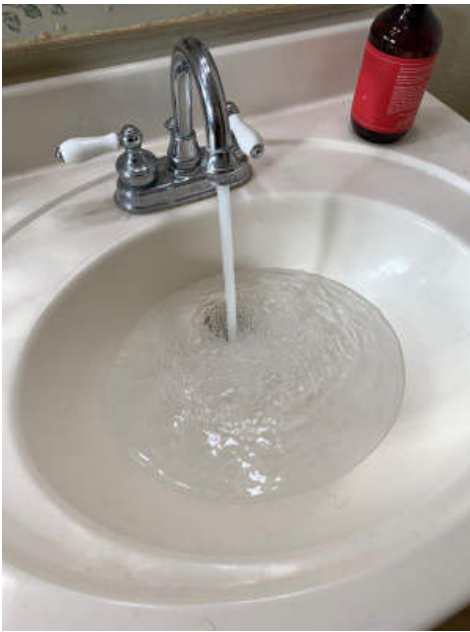
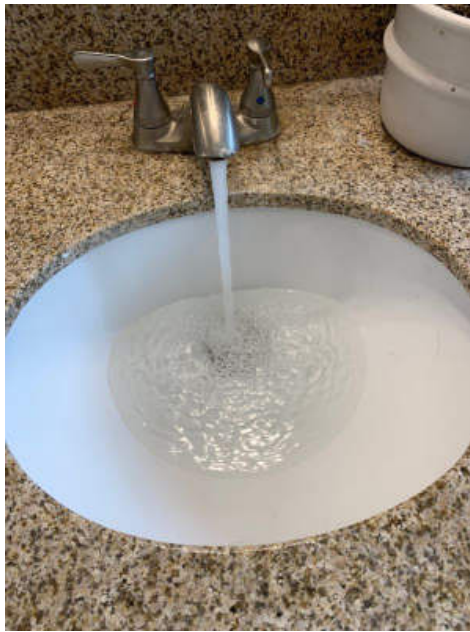
#### 9.2.1 Drain, Waste, & Vent Systems **SINK - POOR DRAINAGE**

Sink(s) had slow/poor drainage. Recommend a qualified plumber repair.

Recommendation  
Contact a qualified plumbing contractor.

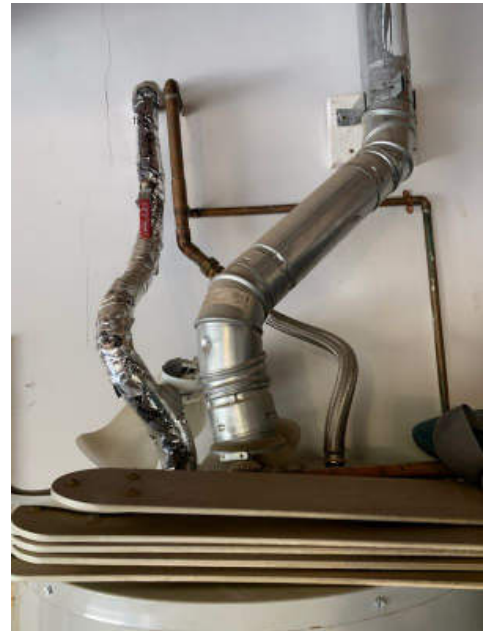
#### 9.4.1 Hot Water Systems, Controls, Flues & Vents

### NO EXPANSION TANK

No expansion tank was present. Expansion tanks allow for the thermal expansion of water in the pipes. These are required in certain areas for new installs. Recommend a qualified plumber evaluate and install.

Contact a qualified plumbing contractor.

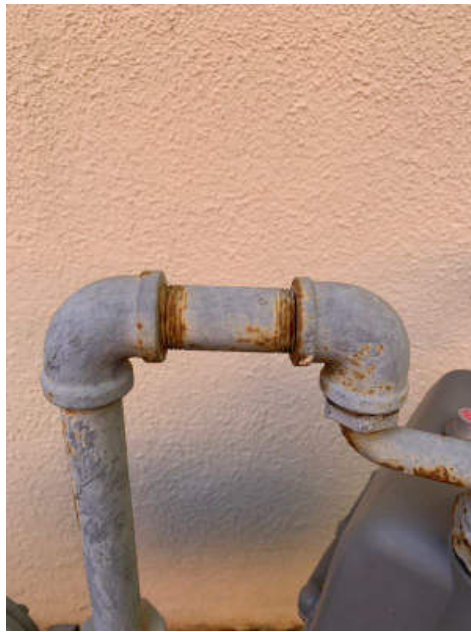
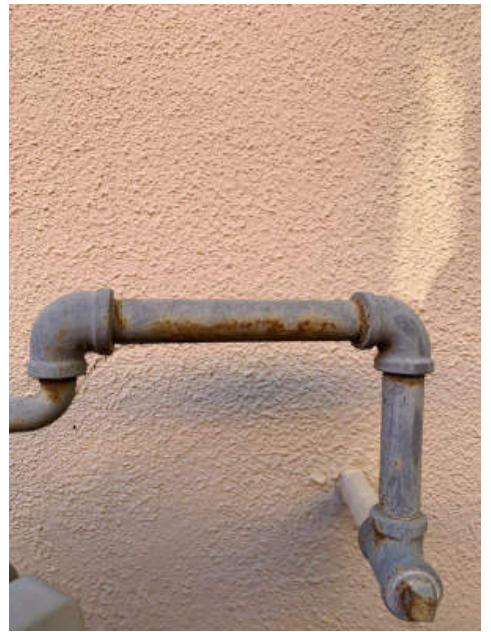
#### 9.5.1 Fuel Storage & Distribution Systems

### CORROSION

Gas pipes were corroded. This can lead to gas leaks. Recommend contacting local utility company for evaluation and repair.

Contact your local utility company

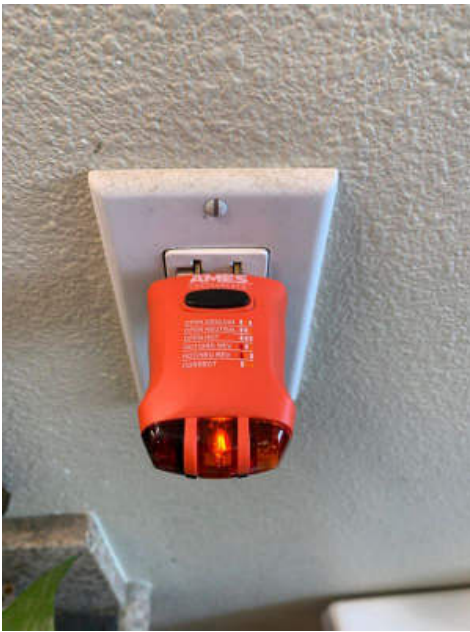
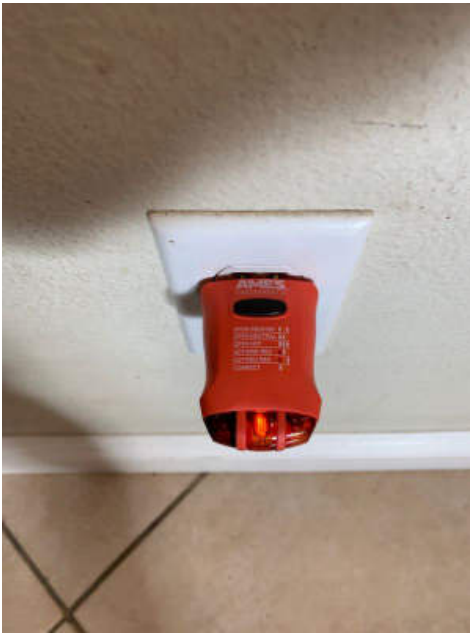
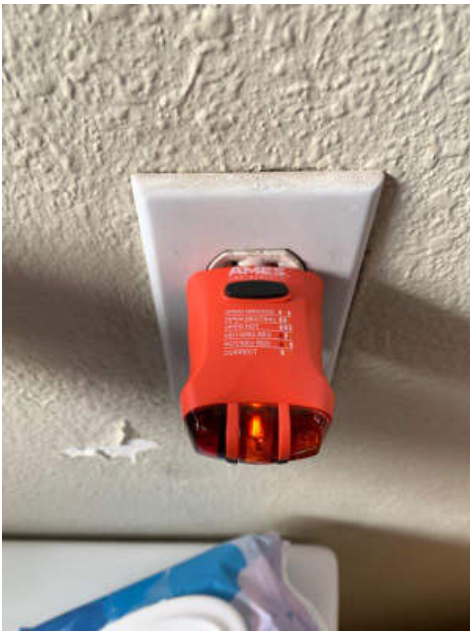
#### 10.4.1 Lighting Fixtures, Switches & Receptacles

##### **UNGROUND RECEPTACLE**

One or more receptacles were ungrounded. Recommend receptacles in kitchen, bathrooms, garage & exterior be grounded to minimize risk of electrical fire.

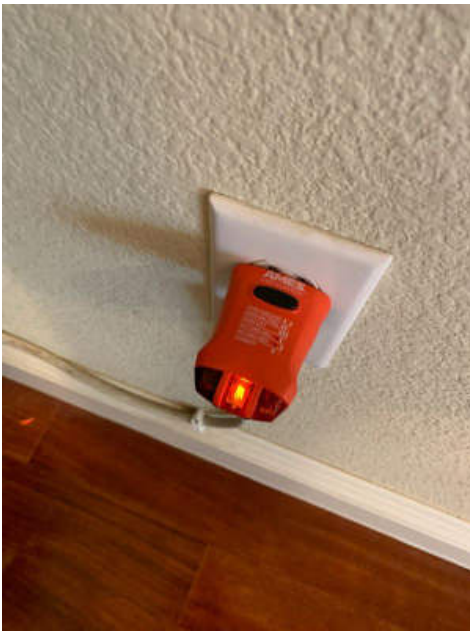
10.5.1 GFCI & AFCI  
**NO GFCI PROTECTION INSTALLED**

No GFCI protection was observed in some/all key locations. Recommend licensed electrician upgrade by installing ground fault receptacles in any location that has a higher risk of liquid exposure.

Recommendation  
Contact a qualified electrical contractor.

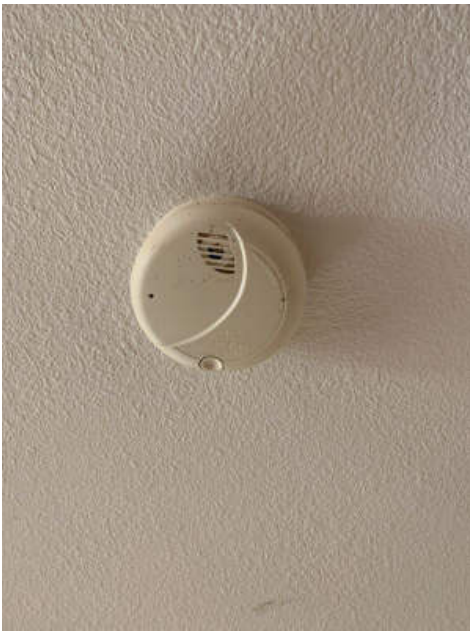
10.6.2 Smoke Detectors

**LOW BATTERY**

Smoke detector failed to respond when tested. Recommend battery be replaced.

Recommendation  
Recommended DIY Project

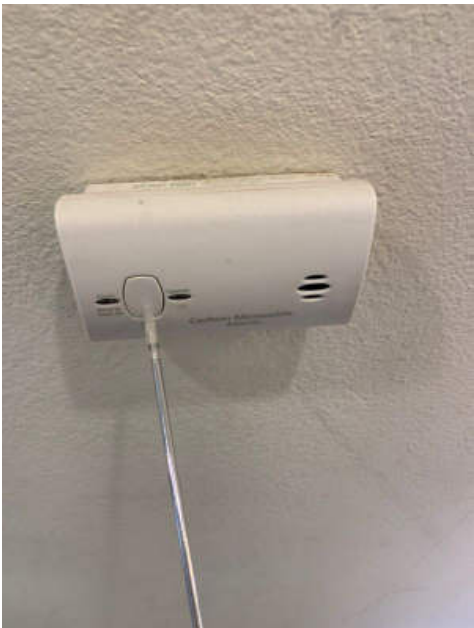
10.7.1 Carbon Monoxide Detectors

**POSSIBLY DEFECTIVE**

Carbon monoxide detector is connected, but not functioning properly. Carbon monoxide detectors should be replaced every 5 years. Recommend replacement if defective.

Recommendation  
Recommended DIY Project

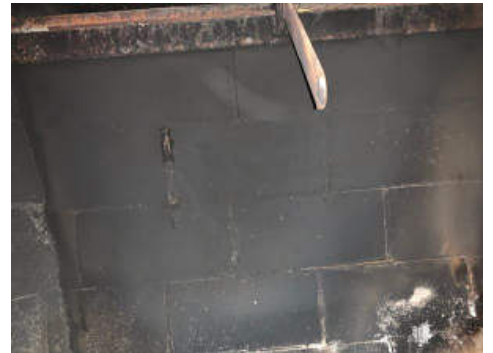
## 11.3.1 Damper Doors

### DAMPER INOPERABLE

Damper was inoperable. Recommend a qualified fireplace contractor repair.

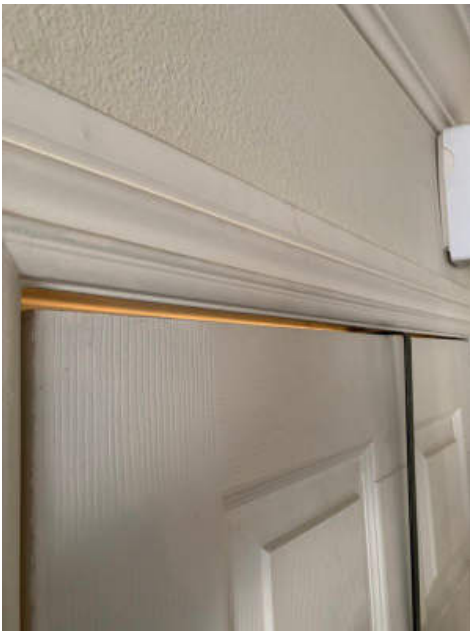
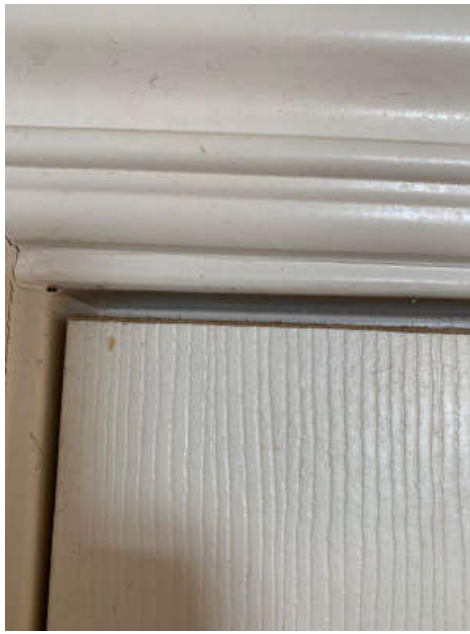
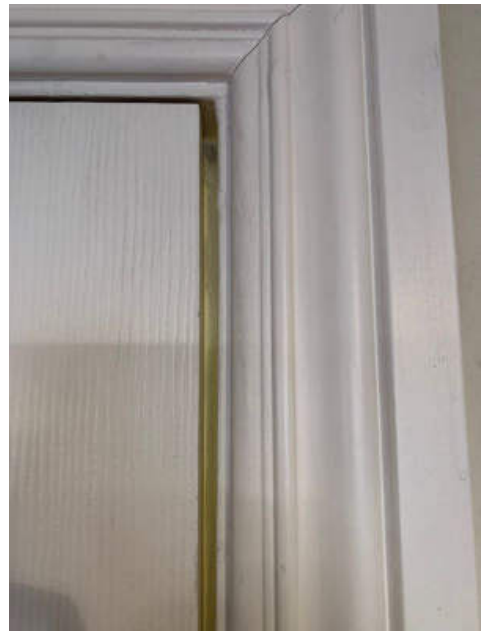
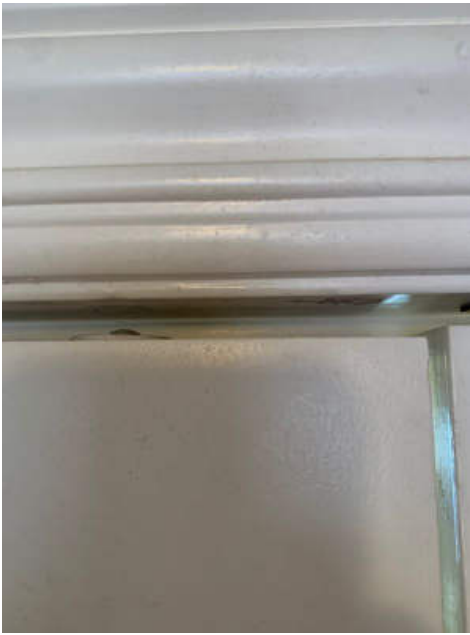
## 13.1.1 Doors

### NOTICEABLE GAP

Recommend handyman or door contractor evaluate.

Contact a qualified handyman.
