## SUMMARY

1234 Main Street Riverside CA 92507

Jeremy Gutierrez  
InterNACHI Certified Professional  
Inspector®  
WestCo Home Inspection, LLC  
(858) 333-4248  
[jg@wchinspection.com](mailto:jg@wchinspection.com)

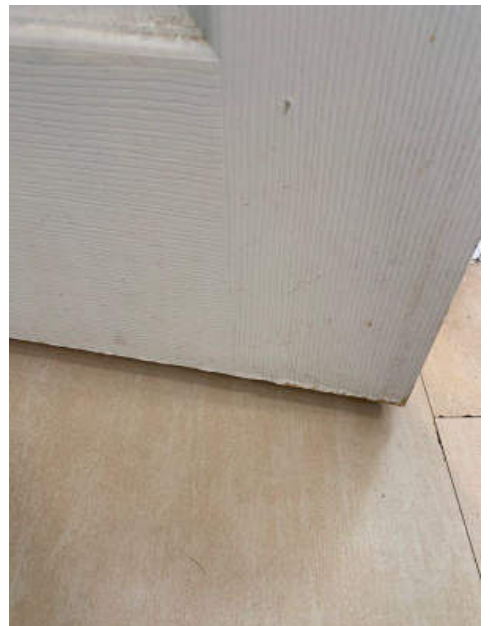
### 13.1.2 Doors

#### **WATER STAINING**

Door shows noticeable water staining, which could lead to further deterioration. Monitor for future repair or replacement.

Contact a qualified handyman.

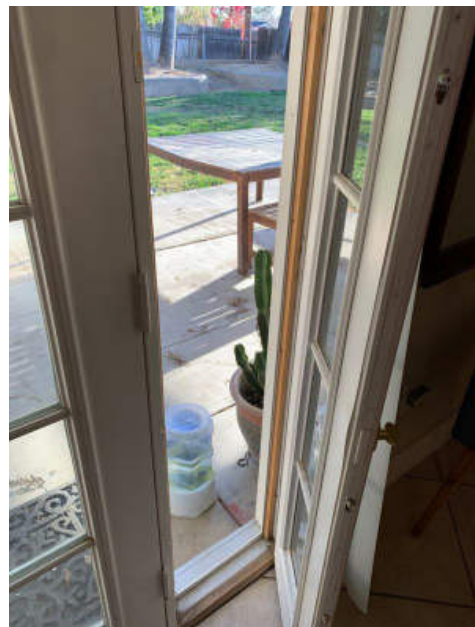
### 13.2.1 Windows

#### MISSING SCREEN

Window missing screen. Recommend replacement.

Contact a handyman or DIY project

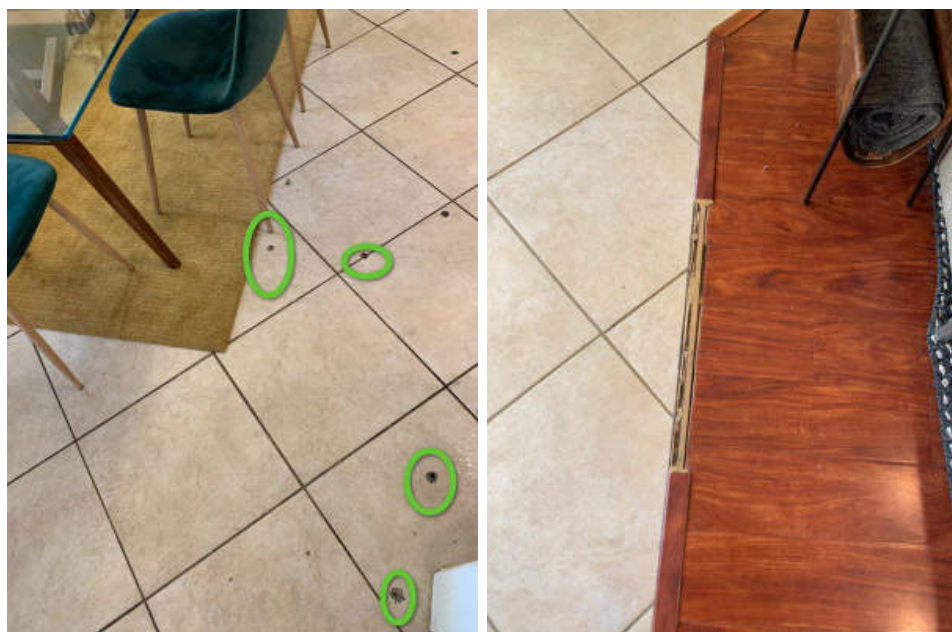
### 13.3.1 Floors

#### DAMAGED (GENERAL)

The home had general moderate damage visible at the time of the inspection. Recommend service by a qualified contractor.

Contact a qualified professional.

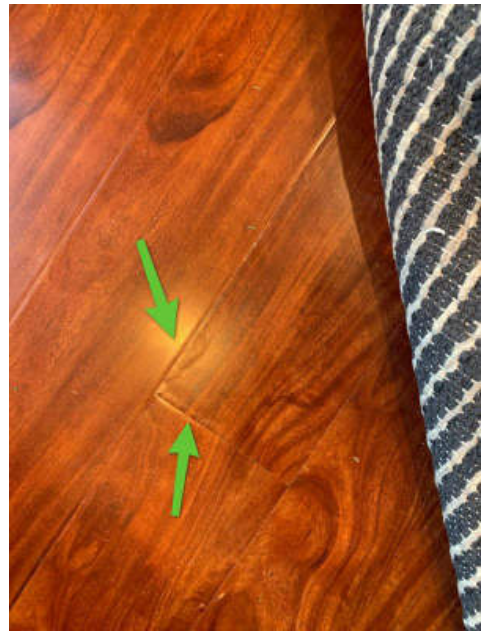
### 13.3.3 Floors

## MOISTURE DAMAGE

Floors had areas of visible moisture damage. Recommend a qualified flooring contractor evaluate & repair areas of moisture.

Contact a qualified professional.

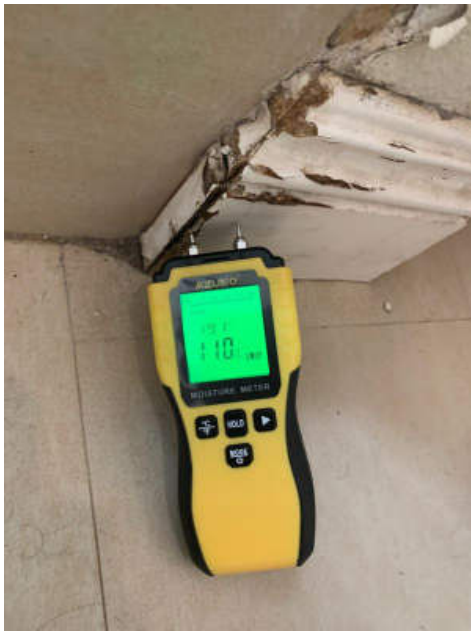
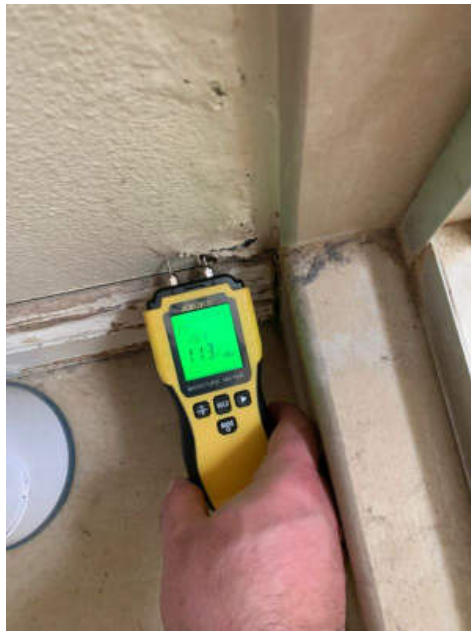
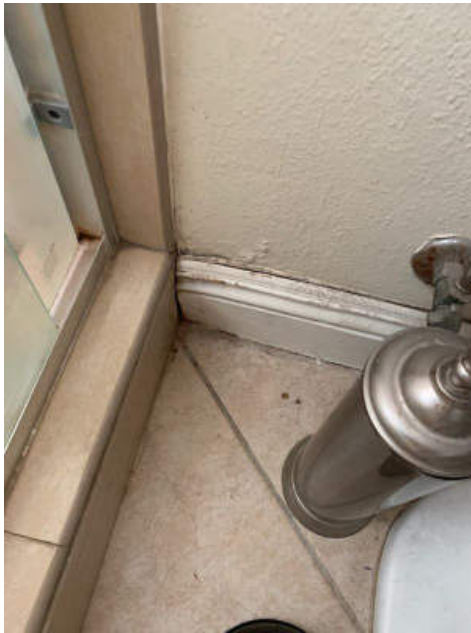
### 13.4.2 Walls

## MOISTURE DAMAGE

Stains on the walls visible at the time of the inspection appeared to be the result of moisture intrusion. The source of moisture may have been corrected. Recommend further examination by a qualified contractor to provide confirmation.

Contact a qualified professional.

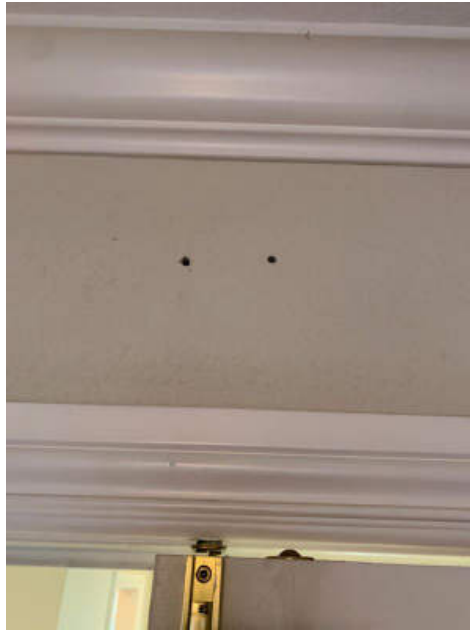
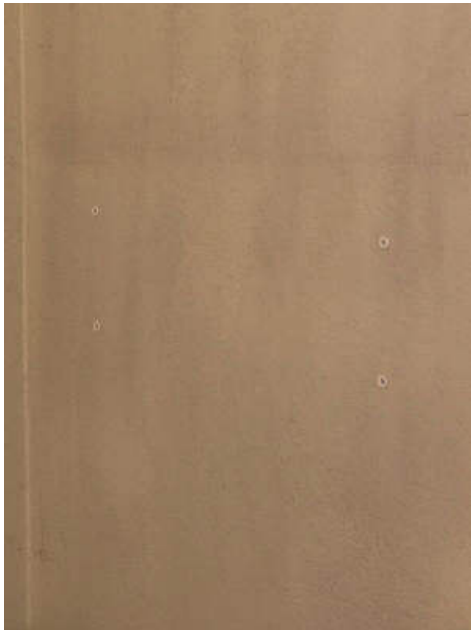
#### 13.5.1 Ceilings

### MINOR DAMAGE

Minor damage or deterioration to the ceiling was visible at the time of the inspection.

Contact a handyman or DIY project

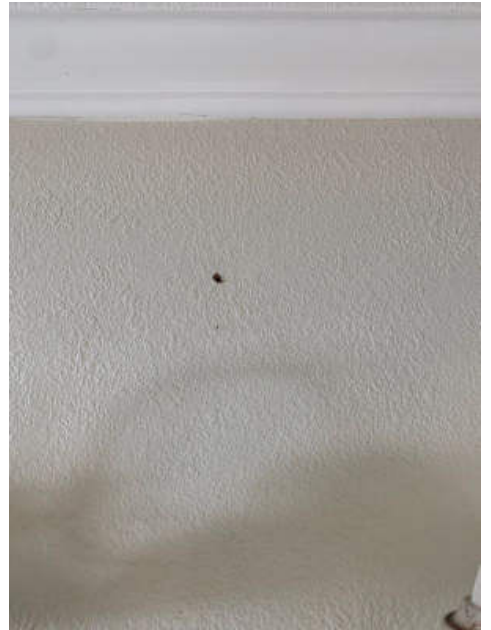
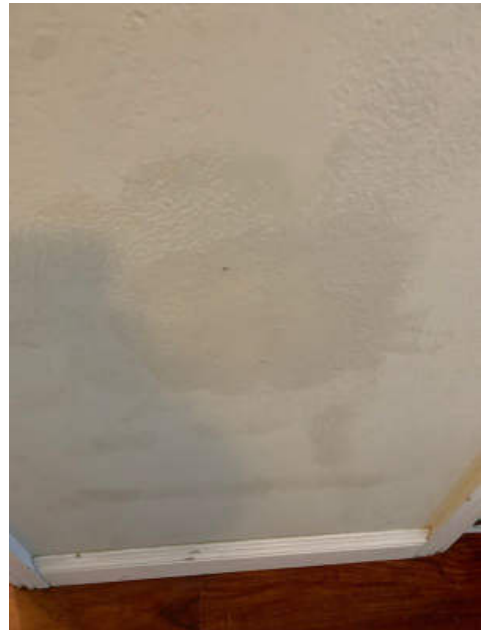
#### 13.4.4 Walls

### POOR PATCHING

Sub-standard drywall patching observed at time of inspection. Recommend re-patching.

Contact a handyman or DIY project

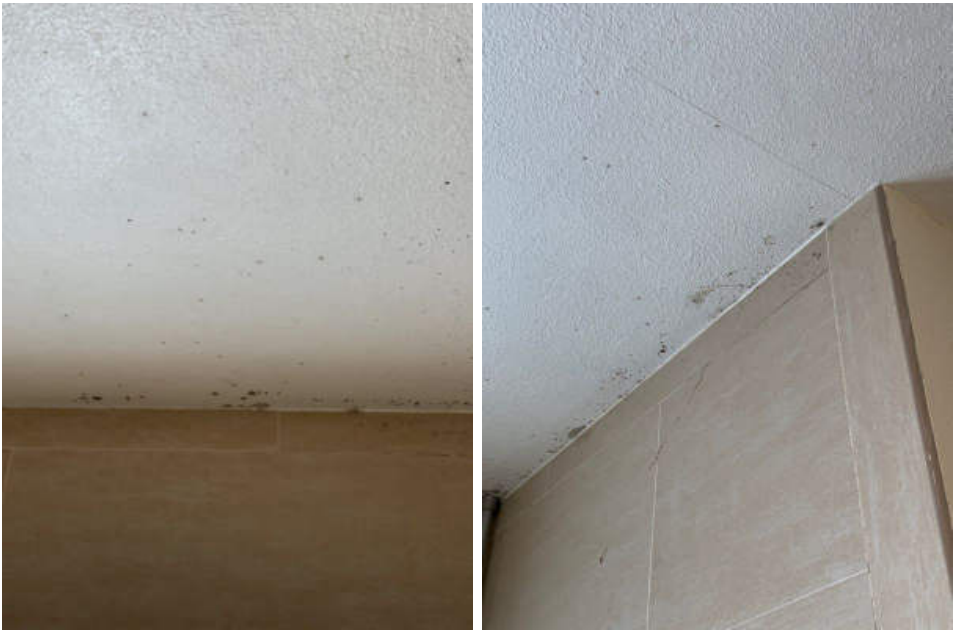
13.5.2 Ceilings  
**POSSIBLE MOLD**

There are possible signs of fungi growth on ceiling. It is unknown if this is a safety hazard. Recommend a qualified mold inspector evaluate.

Recommendation  
Contact a qualified mold inspection professional.

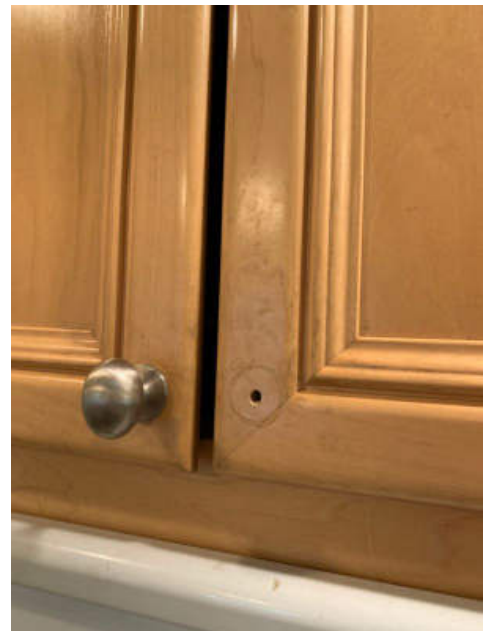
#### 13.6.1 Countertops & Cabinets

### **CABINET HANDLE MISSING**

One or more cabinet handles were missing.

Recommended DIY Project
